# Expert Opinion Report - Rectification

10-12 View Point Road, McCrae

PSM5226-005R 11 June 2024

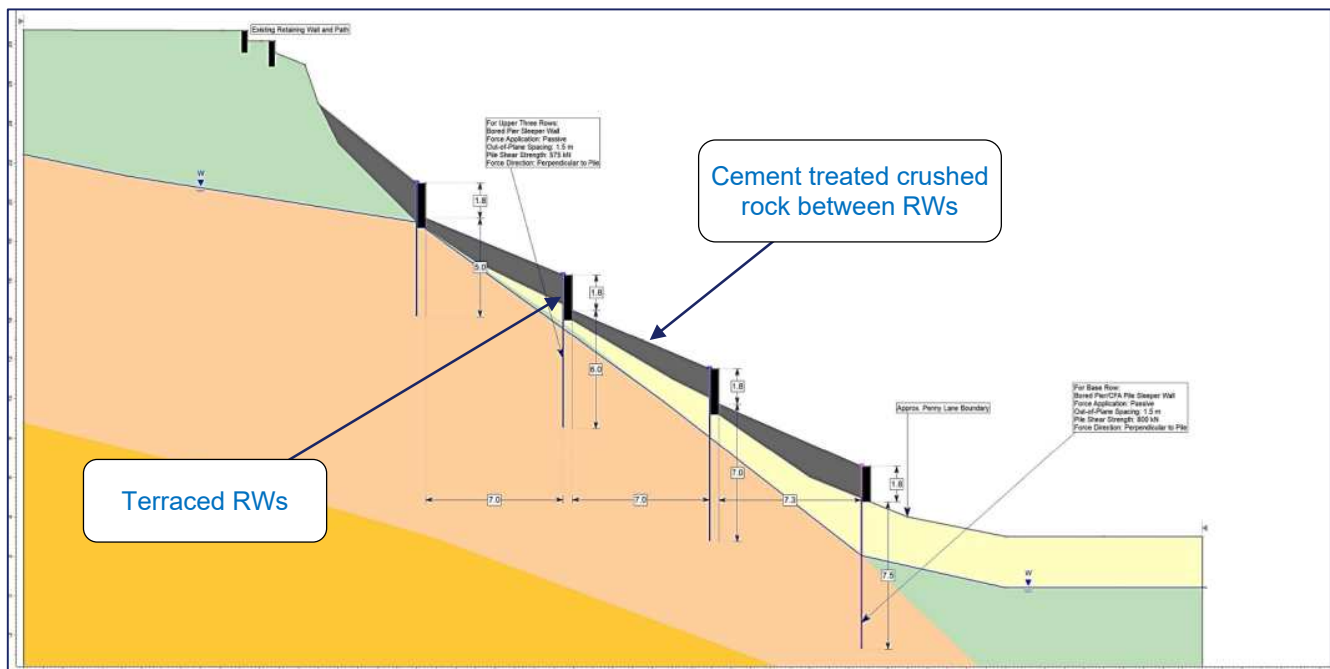
**Inset 4:** CivilTest section with proposed RW remediation (Document 12, pdf page 29). I have added my commentary in blue.

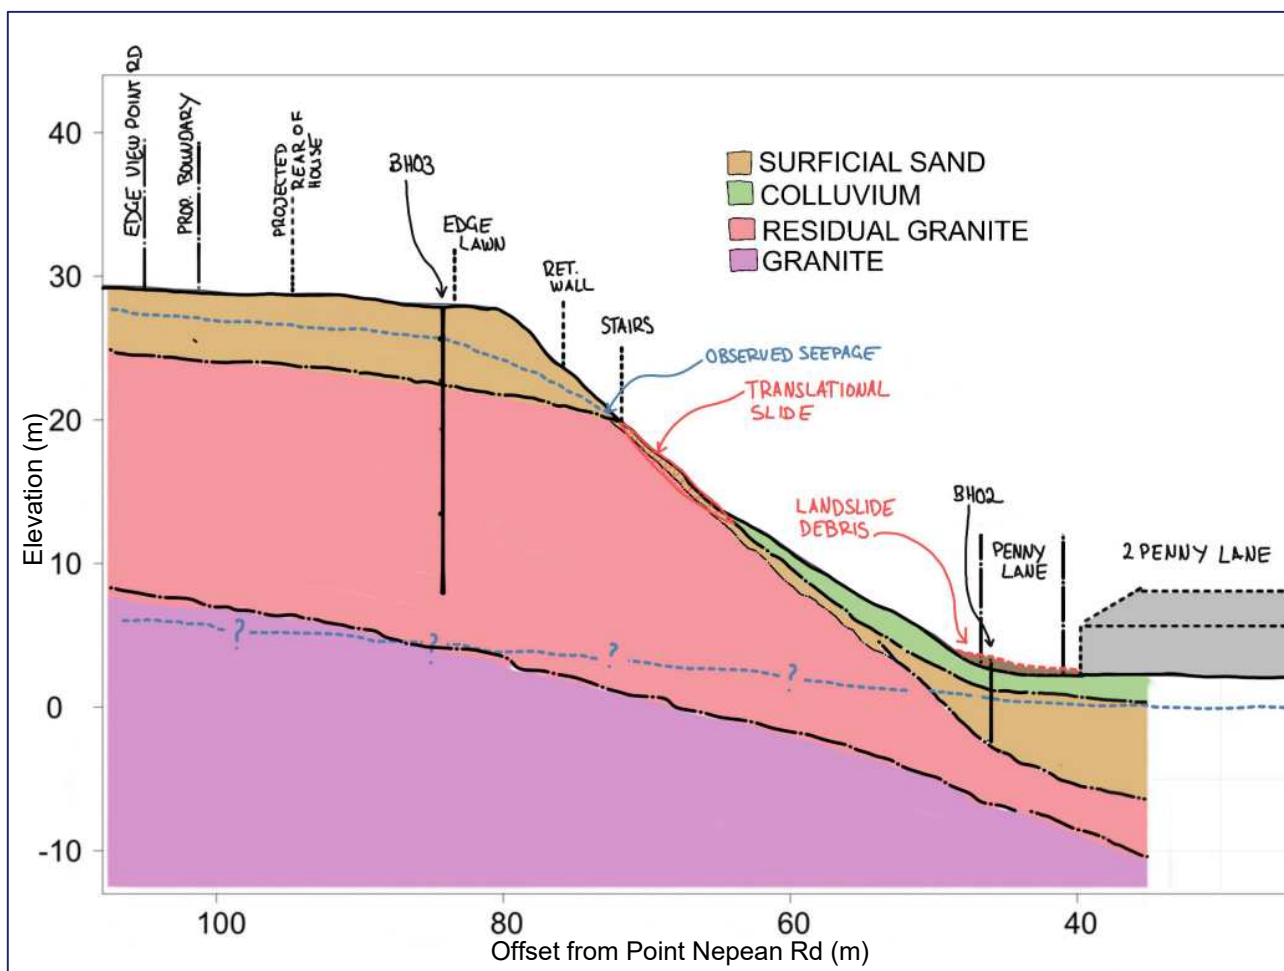
38. My interpretation of the geological conditions is presented in Inset 9. With regards to the geotechnical model, I note the following key observations:

- (a) There is uncertainty regarding the contact between the SURFICIAL SAND and the RESIDUAL GRANITE owing to the likelihood of some of the parent material of the SURFICIAL SAND being derived from erosion of the Dromana Granite. I have assumed that the wet soils are an indicator of the contact between the two geotechnical units.
- (b) The laboratory testing indicates that all samples between 3 m and 19 m bgl have very similar Particle Size Distributions, Inset 10, and Atterberg limits indicate low plasticity CLAY fines.

Inset 9: Cross section of my geotechnical model

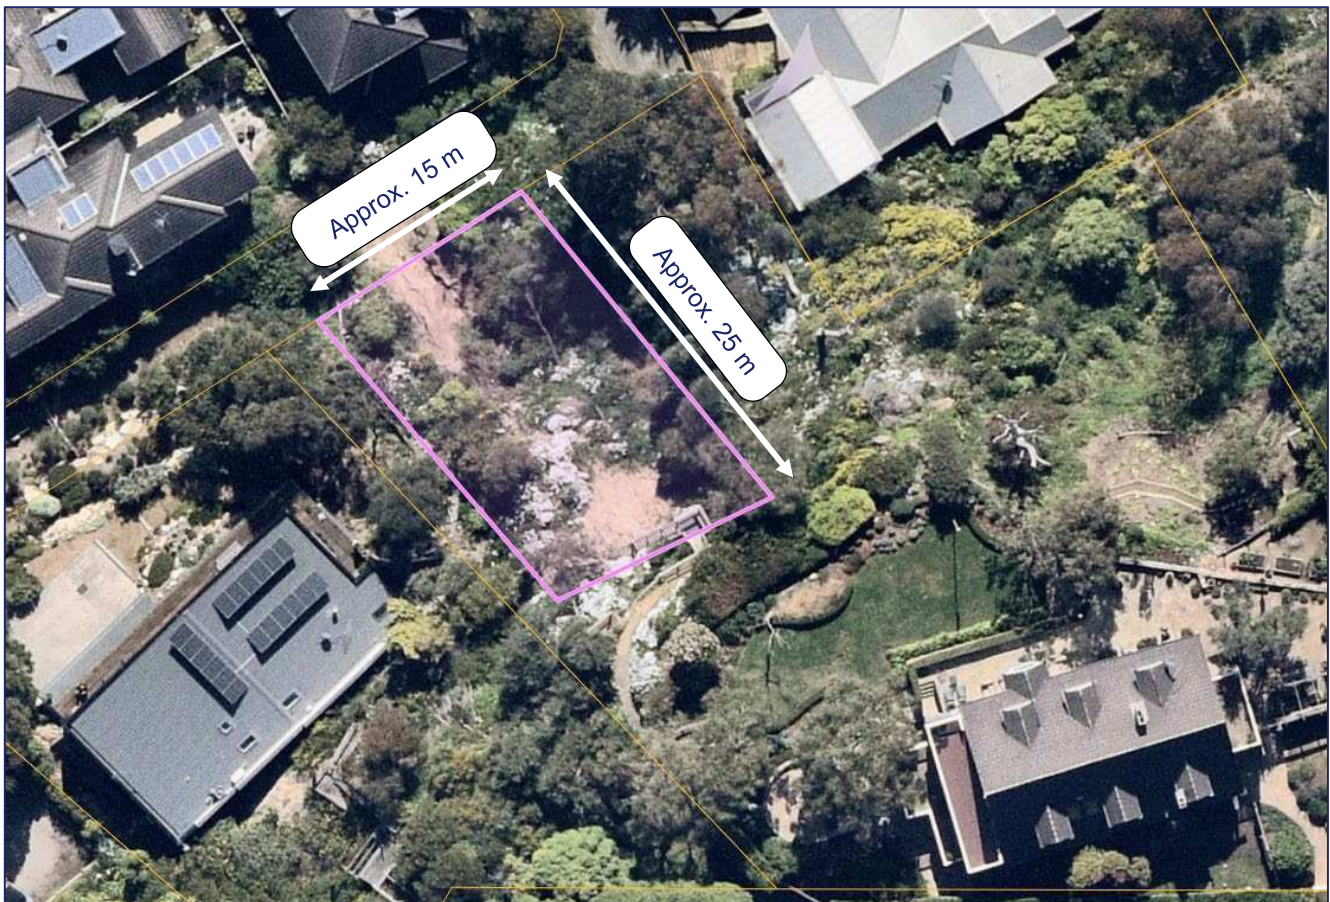
**Inset 16:** Indicative extent of rectification shown in pink (Aerial image from Nearmap)

74. The approximate extent of rectification required is shown in Inset 16. The approximate extents in plan are 15 m wide by 25 m long with 370 m<sup>2</sup> of total area (in plan) to be rectified. I note that the angle of the slope will mean that the actual ground surface area to be rectified is approximately 480 m<sup>2</sup>.
75. The indicated area of rectification extends beyond the observed boundaries of the Landslide to provide stability to the flanks, and to allow for possible uncertainty in the extent of unstable ground (refer to paragraph [26(e)]).

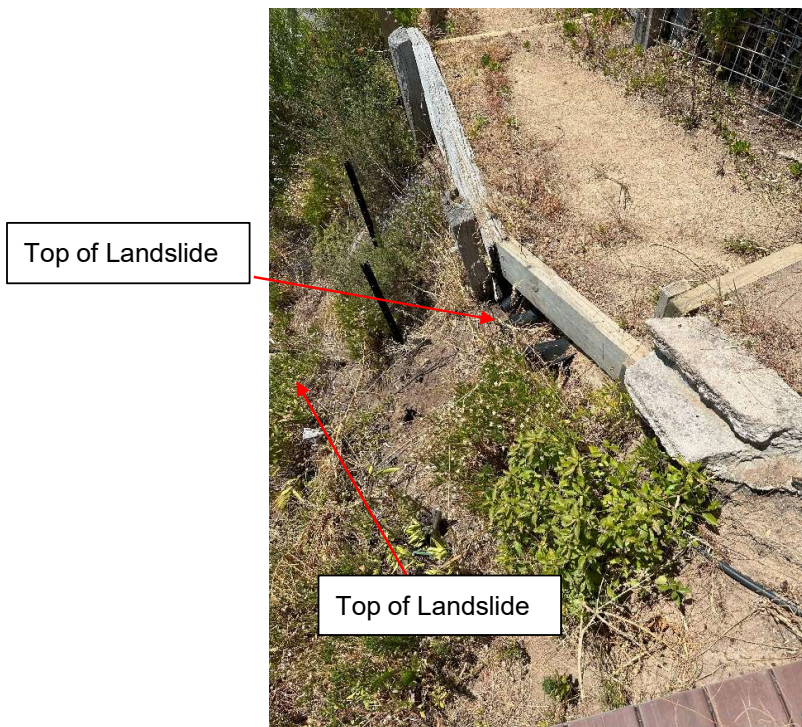
Photo 8 - Path above Landslide, note minor retaining walls and 'agi drains' from Photo 7

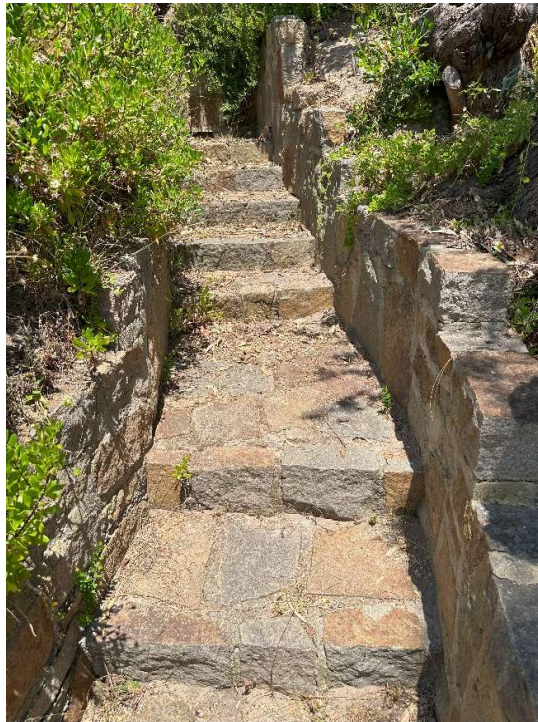
Photo 9 - Granite stairs leading from garden area to path at top of landslide

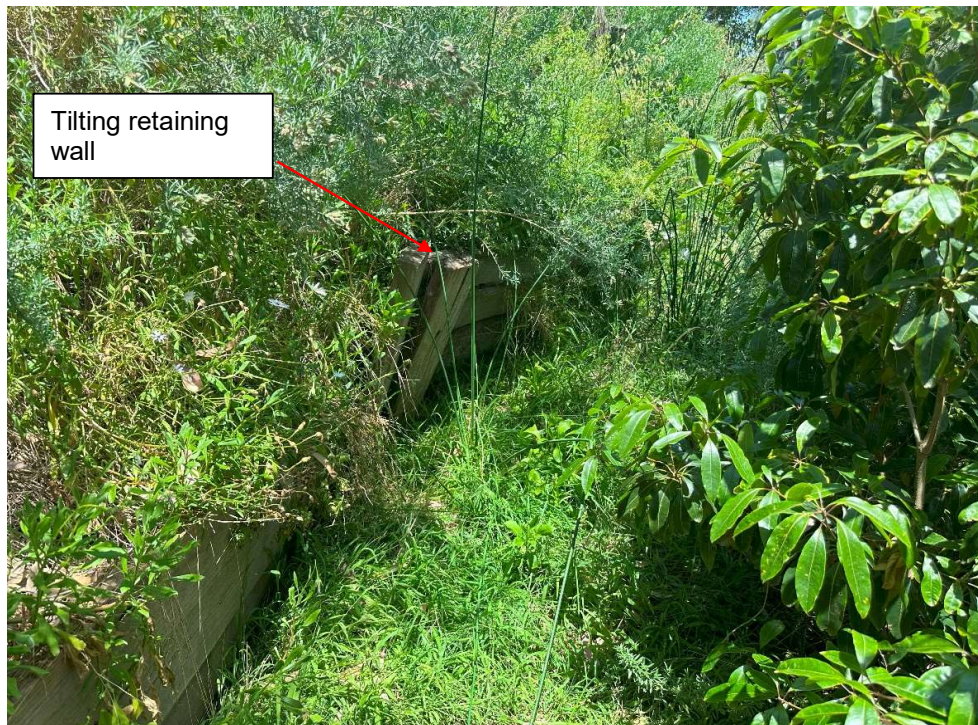
- (g) The condition of RWs across the Site was generally poor, with overturning and bulging RWs observed. A section of RW to the east of the Landslide had significant tilts. This indicates to me possible instability in the ground above the RW and possible structural or geotechnical failure of the RW, Photo 10 Appendix C.

Photo 10 - Tilting retaining walls on left side of Landslide

- (b) The stability of the Surficial Sand slopes above the existing stairs at the crest of the Landslide is excluded, as this is controlled by the performance of P1 RWs. Where the RWs are showing signs of failure, the owner of P1 should address this separately.
