Multidisciplinary Expert Supplementary Report

# Board of Inquiry into McCrae Landslide

Prepared for: Thomson Geer

21 July 2025

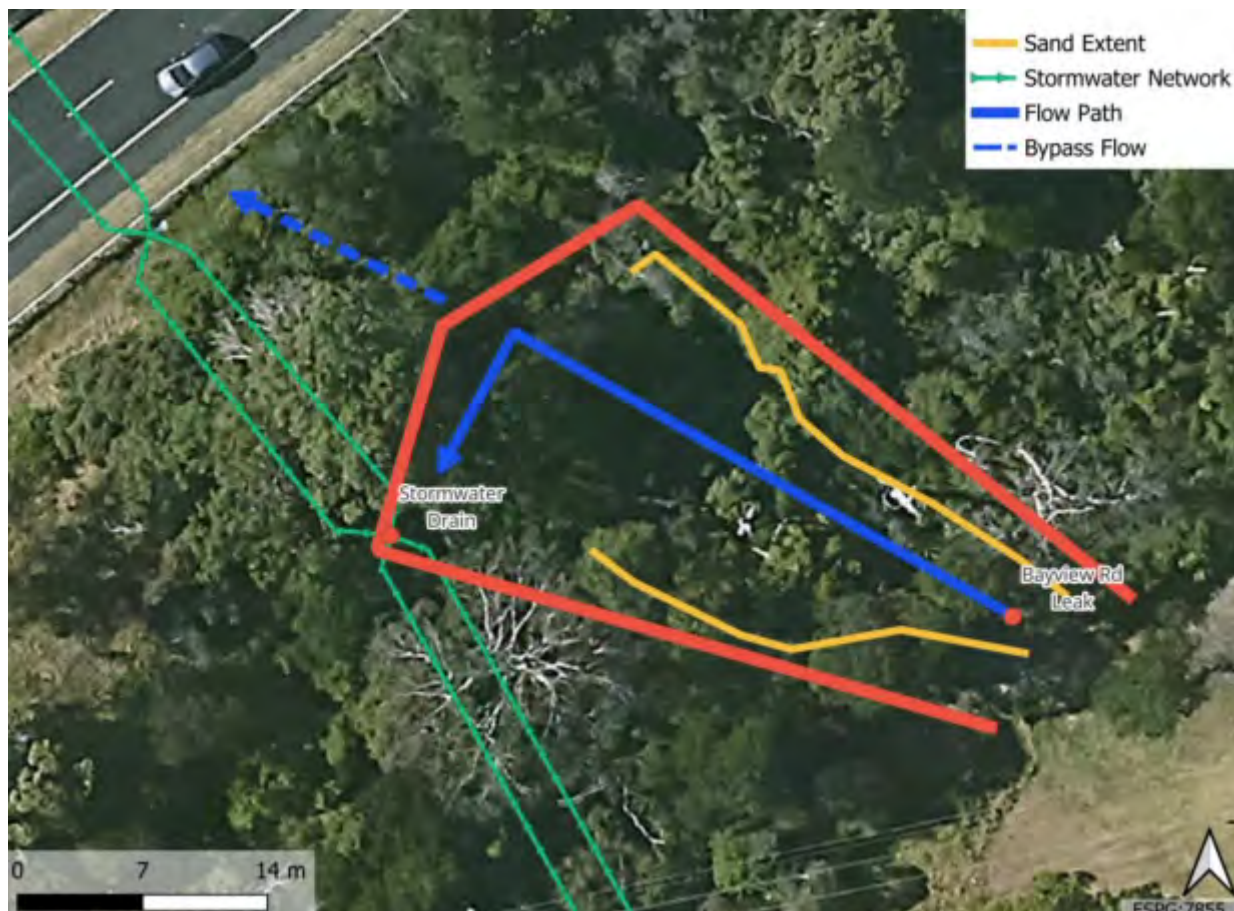
The figure notes a 'bypass flow' continuing north of the stormwater grate and down the cut slope of the M11. It should be noted that the model developed does not represent the channel running parallel to the direction of traffic along the M11, outfalling into the stormwater grate well. Therefore, the lack of visual confirmation that the Bypass flow happened is allowed for by the slight discrepancies of the model. The model outputs note that the Bypass flow accounts for only a small percentage (3% for the 10 L/s model, and 5% of the 20 L/s model) of the overall flow and it is very shallow.

Figure 34: Schematic model of the Bayview Road leak showing surface extents and possible flow paths

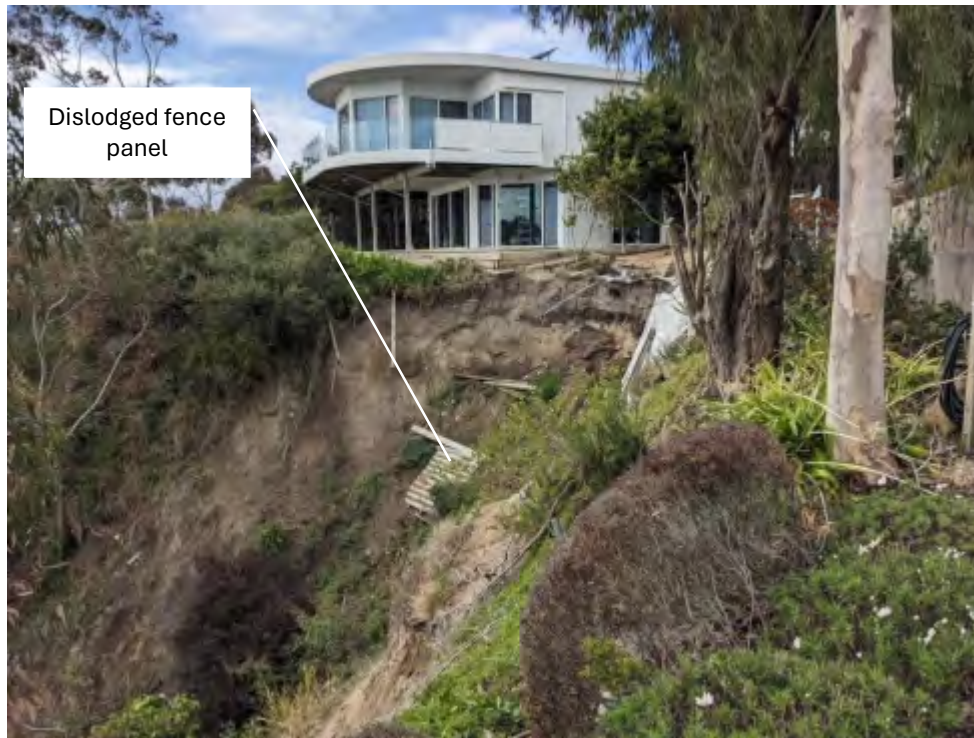
Figure 6: 17/6/25 Photo 03 Looking east showing the upper slope of the escarpment, and assumed extent of slip, showing debris downslope of the backscarp

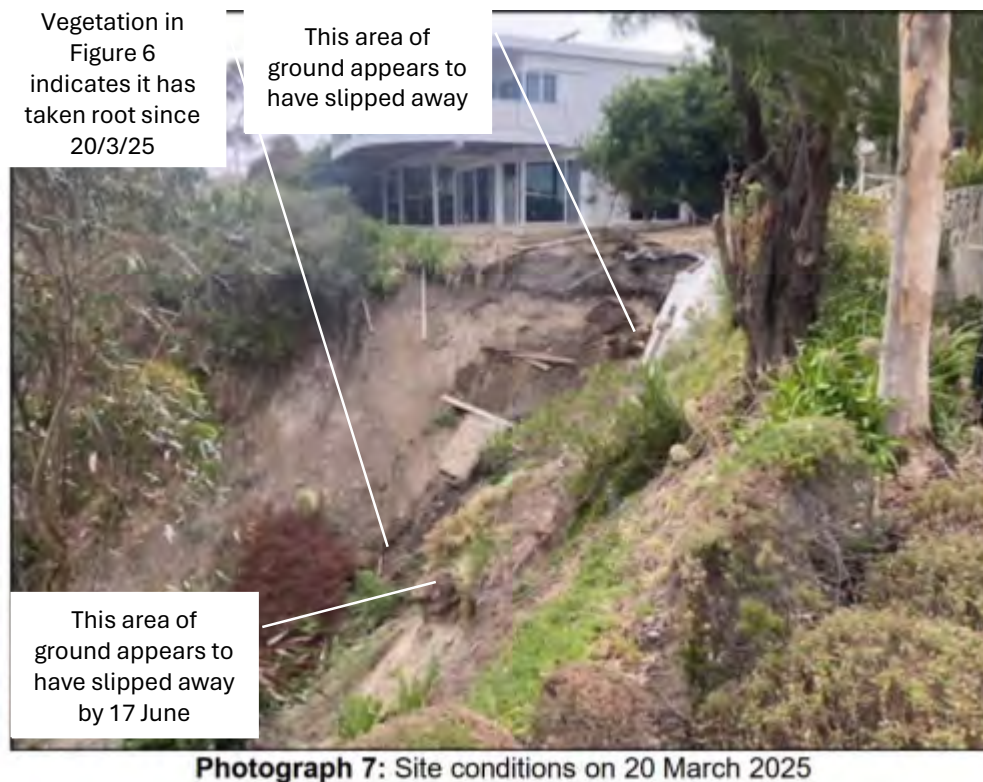
Figure 7 is included to enable the reader to compare a photo taken by CivilTest on 20 March 2025, and included in the CivilTest letter to Mr. Borghesi on 4 April 2025 (Appendix B Ref 4), to Figure 6. Some deterioration appears to have occurred in the time between the two photographs.

Figure 7: 20/3/25 taken from CivilTest Letter dated 4 April 2025 Reference 1222044-15.

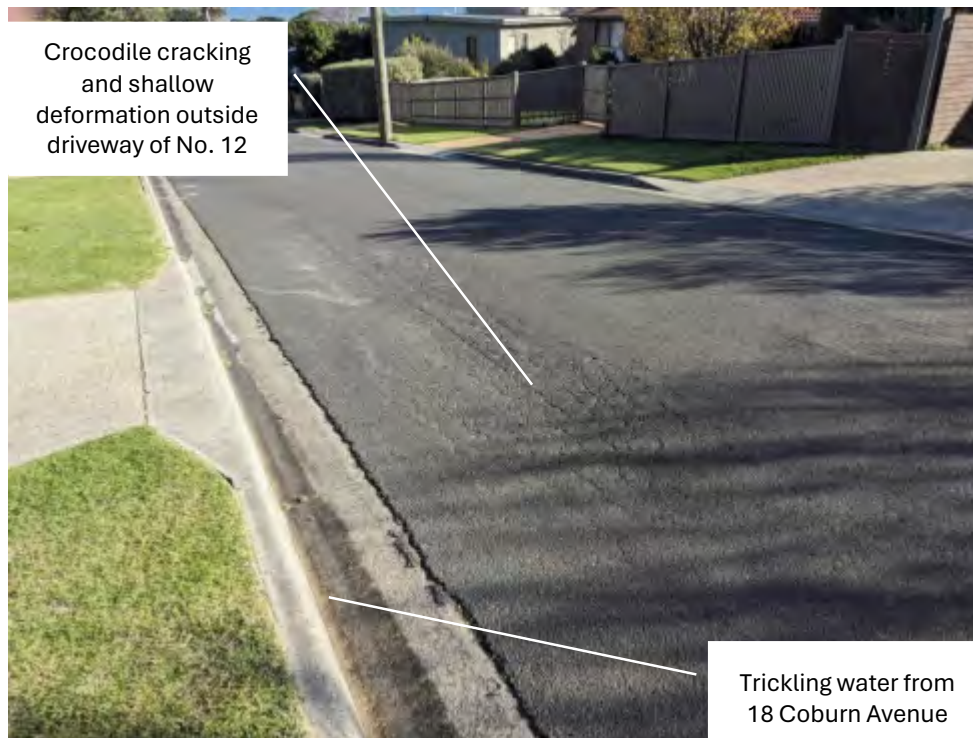
Figure 14: 20/6/25 12 Coburn Avenue, looking west showing condition of pavement

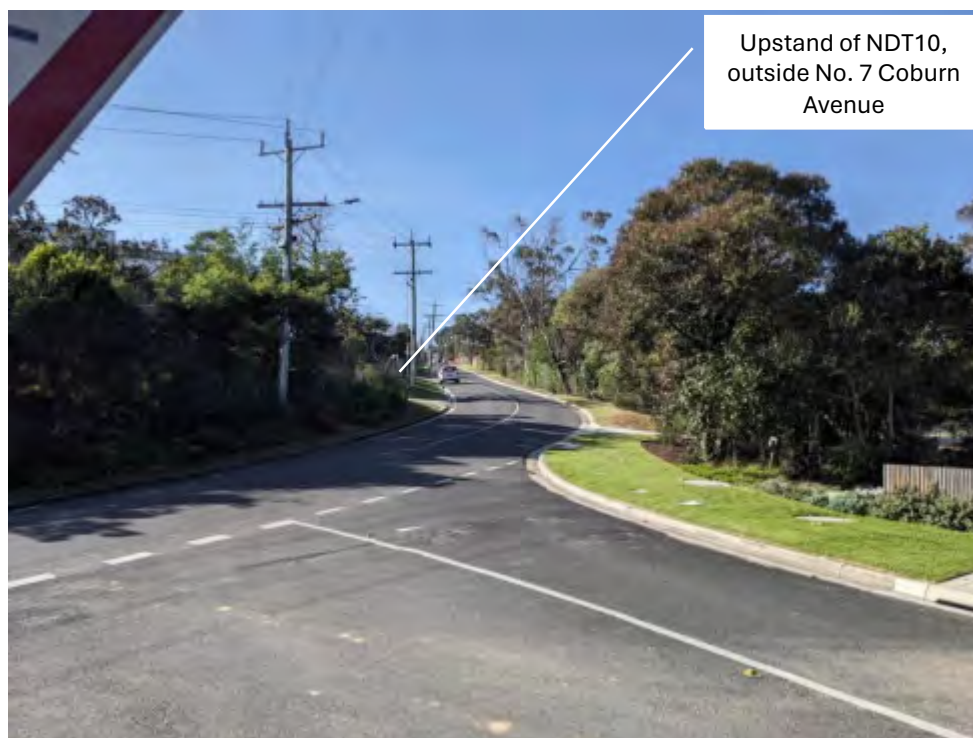
Figure 15: 20/6/25 Coburn Avenue looking east up hill towards NDT10, and location of locally saturated verge.

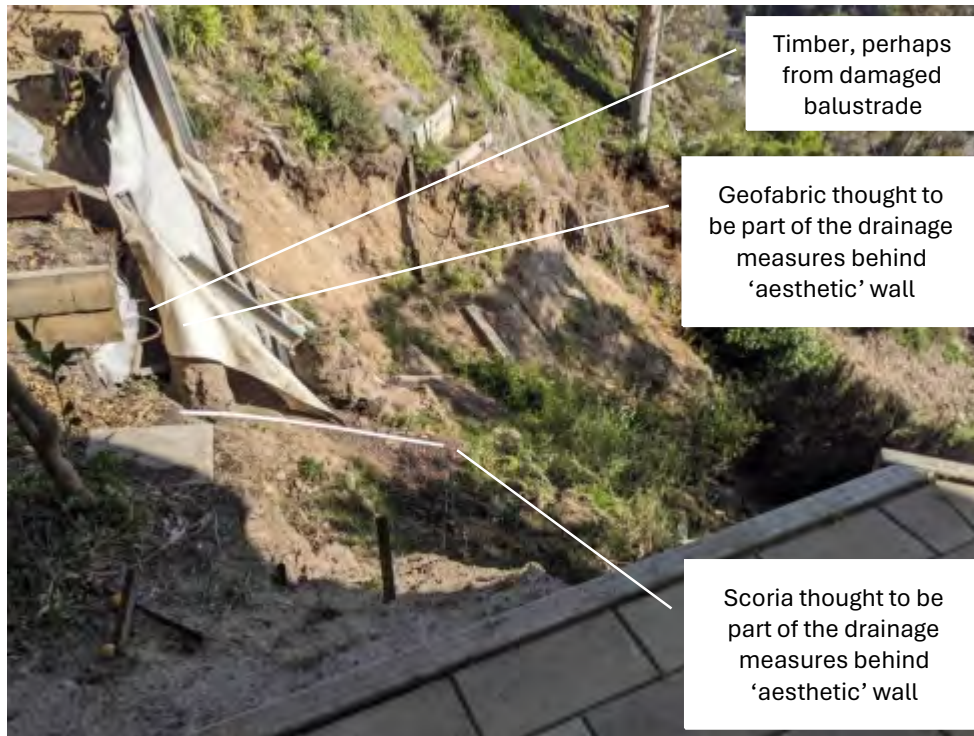
Figure 19: 20/6/25 Looking west showing failed slope material below retaining wall, note the vegetation at the floor of the failed material

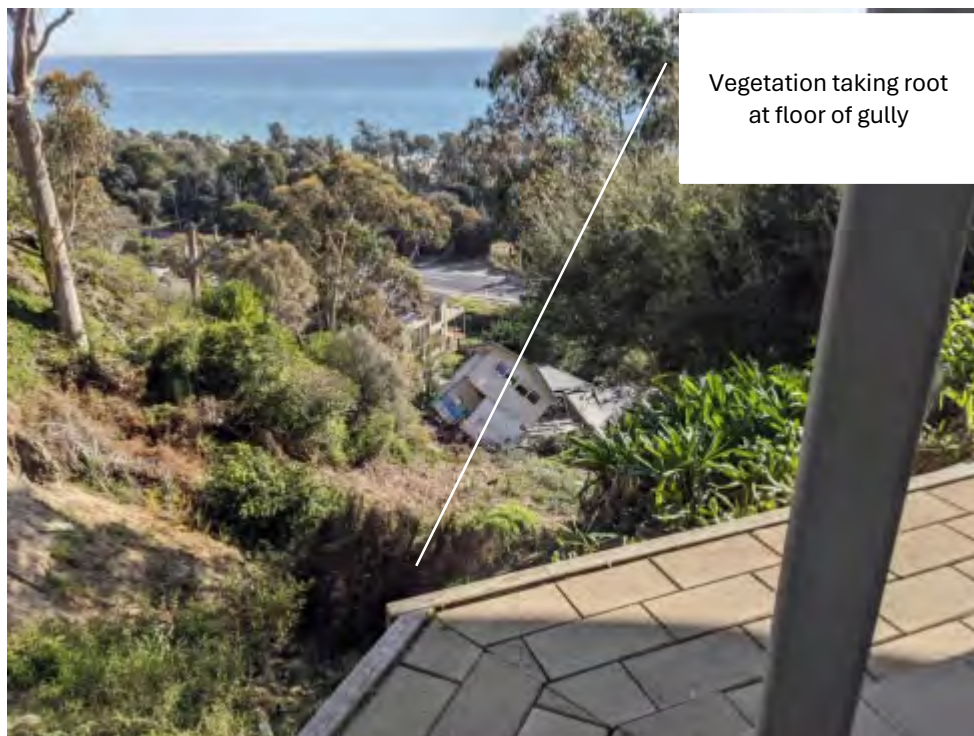
Figure 20: 20/6/25 looking north west showing debris flow towards Penny Lane

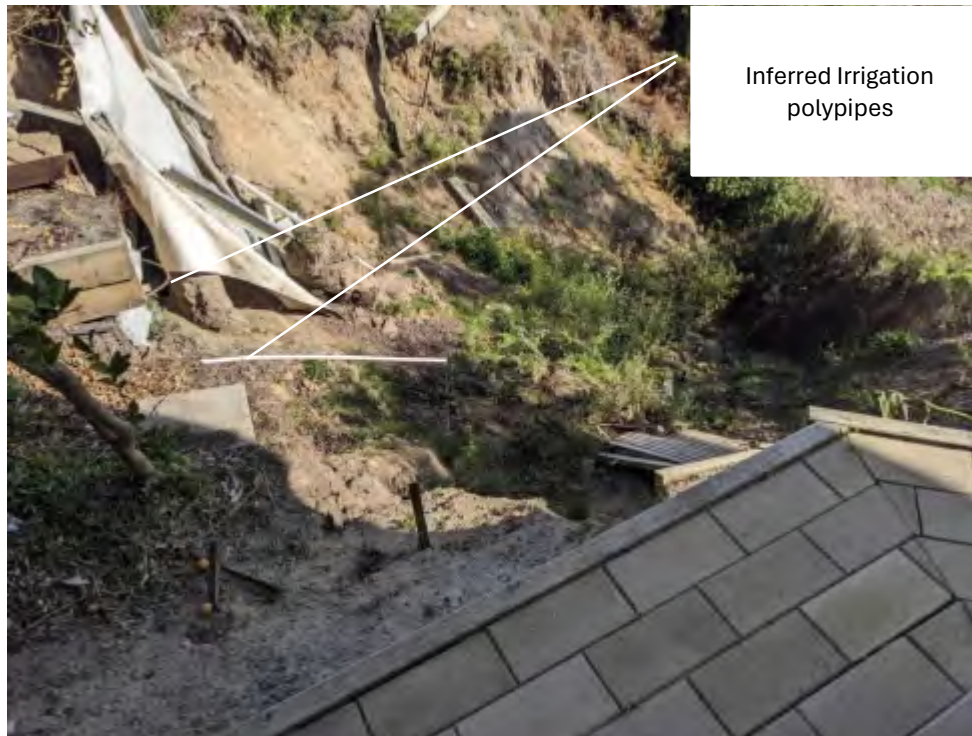
Figure 23: 20/6/25 Looking north west down the failure, showing depth of slope movement.

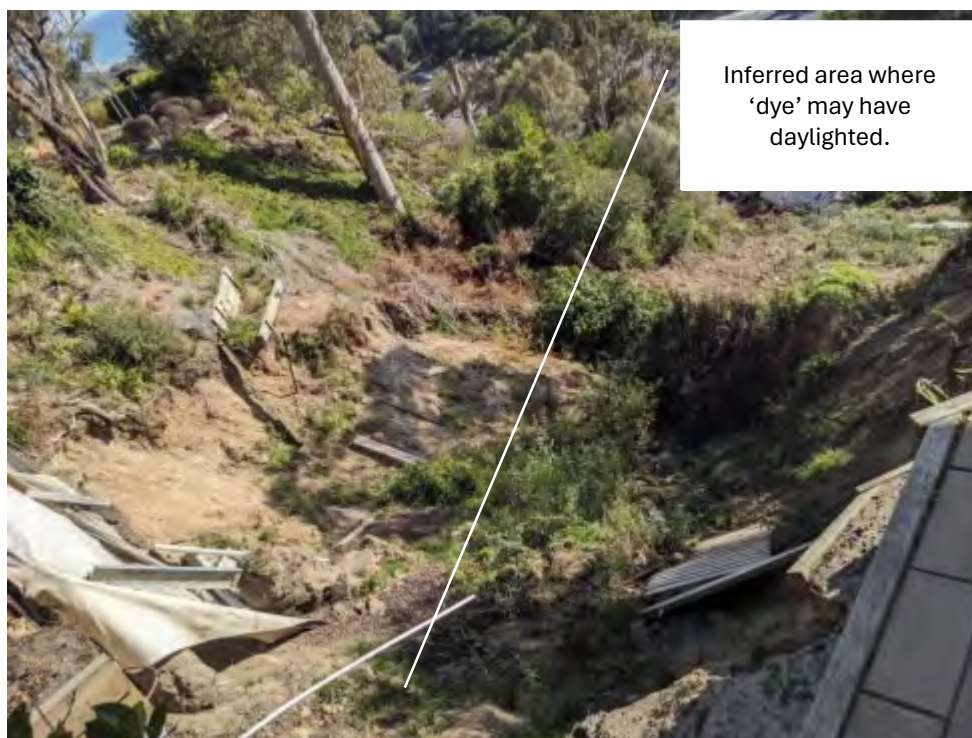
Figure 24: 20/6/25 6 View Point Road, looking north west showing path of landslip

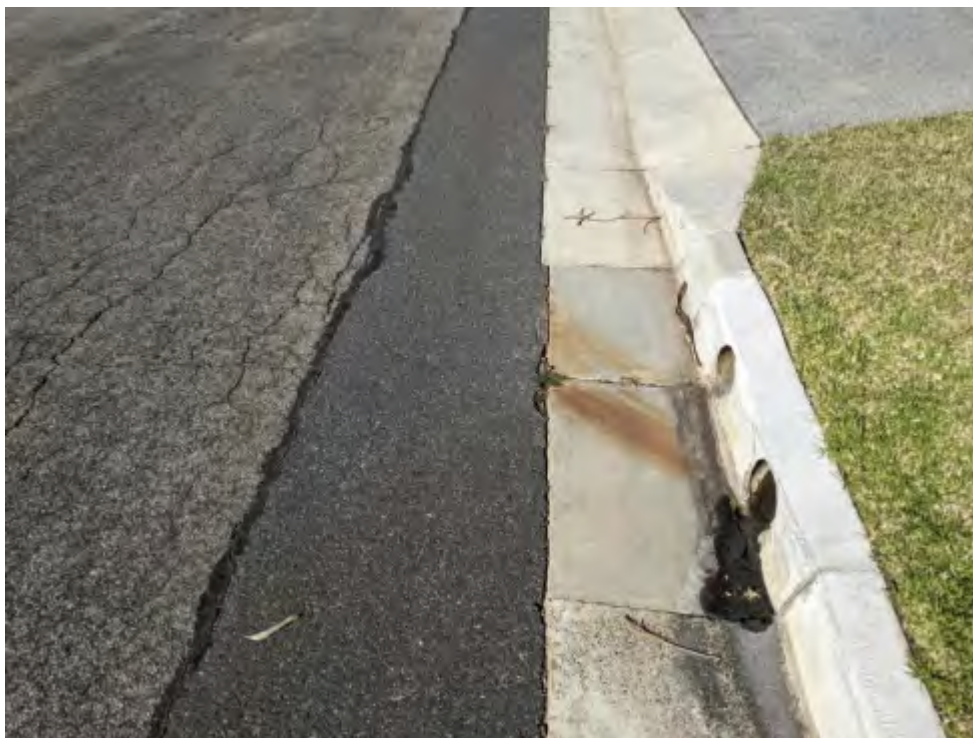
Figure 31: 20/6/25 5 Prospect Hill Road, looking south showing detail of staining flowing from the joint between asphalt and kerb

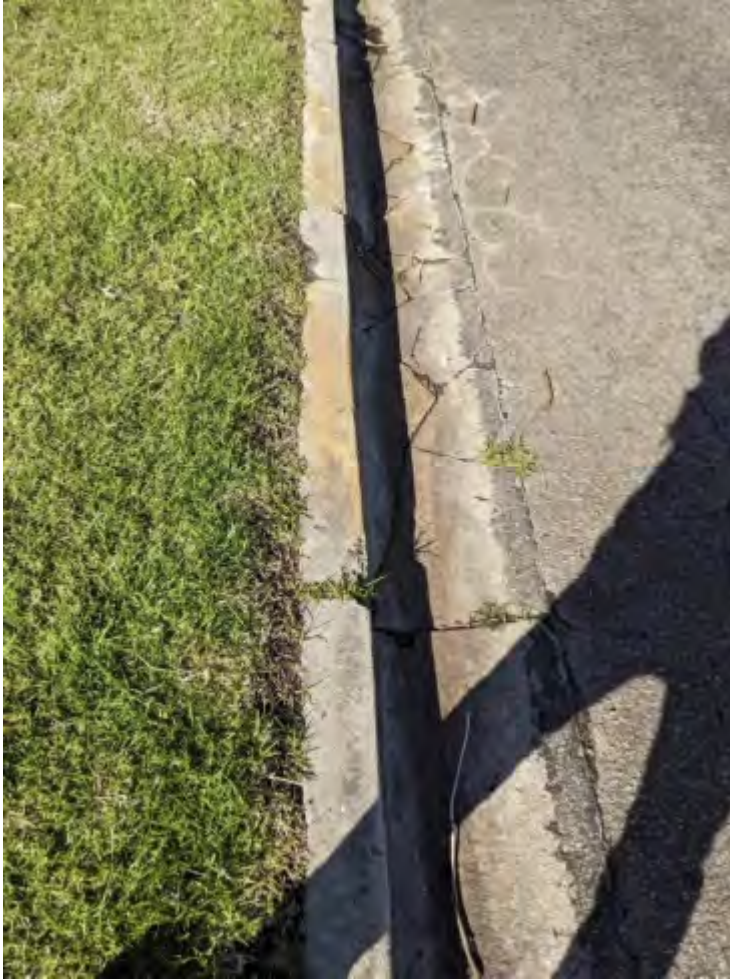
Figure 32: 20/6/25 Looking north from 6 Prospect Hill Road, showing cracking, and staining of kerb suggesting runoff has previously flowed over of kerb.

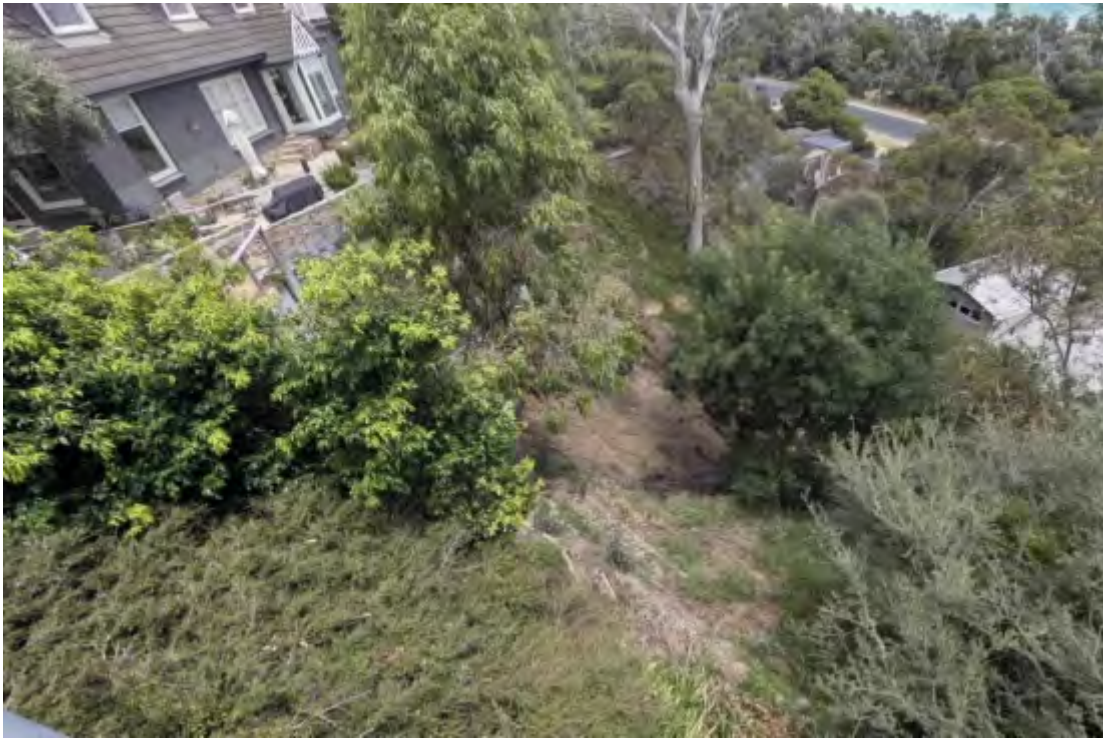
Figure 2: Looking at 5 January 2025 failure, taken on 7 January 2025 by Kevin Hutchings

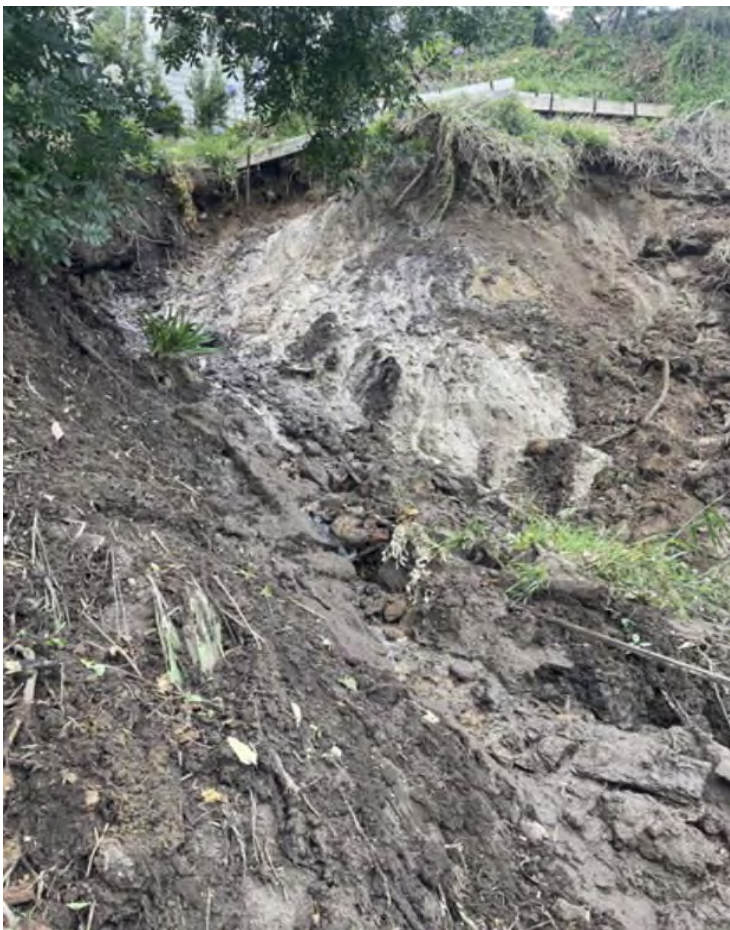
Figure 3: Photo taken by SEW personnel 6 January 2025 showing landslide from midslope of 10-12 View Point Road

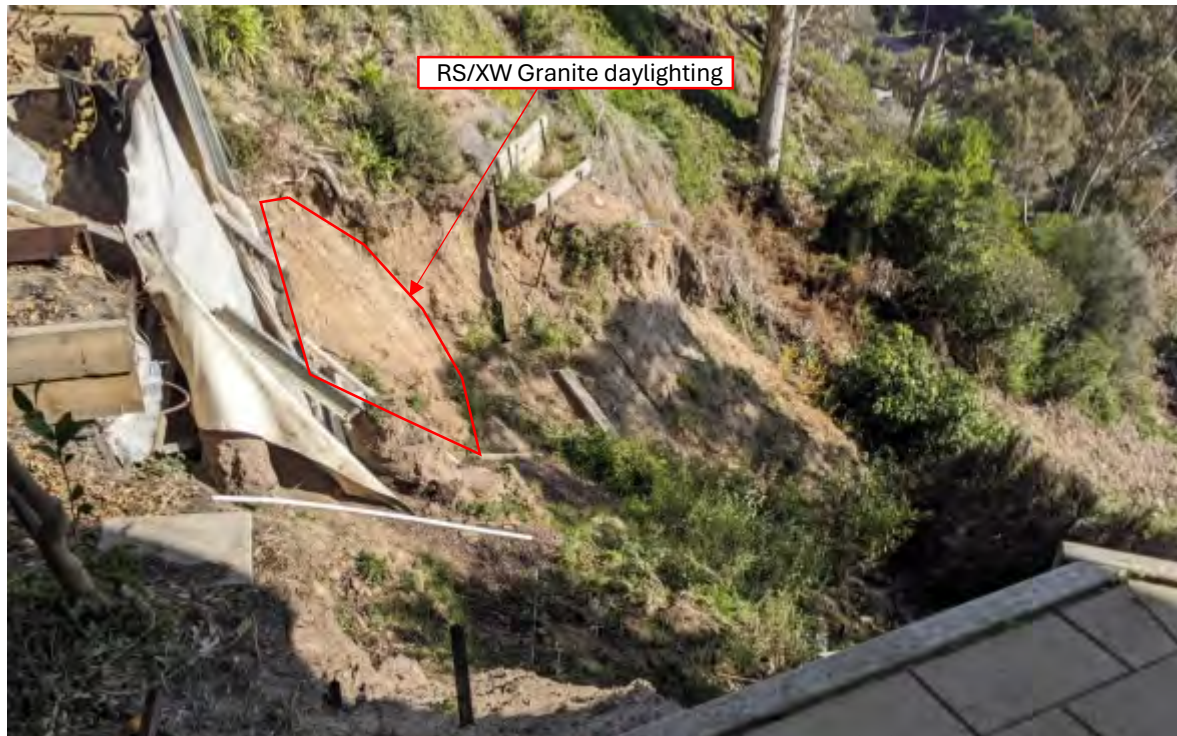
Figure 8: Site photograph looking at backscarp from 6 View Point Road
