Multidisciplinary Expert Supplementary Report

# Board of Inquiry into McCrae Landslide

Prepared for: Thomson Geer

21 July 2025

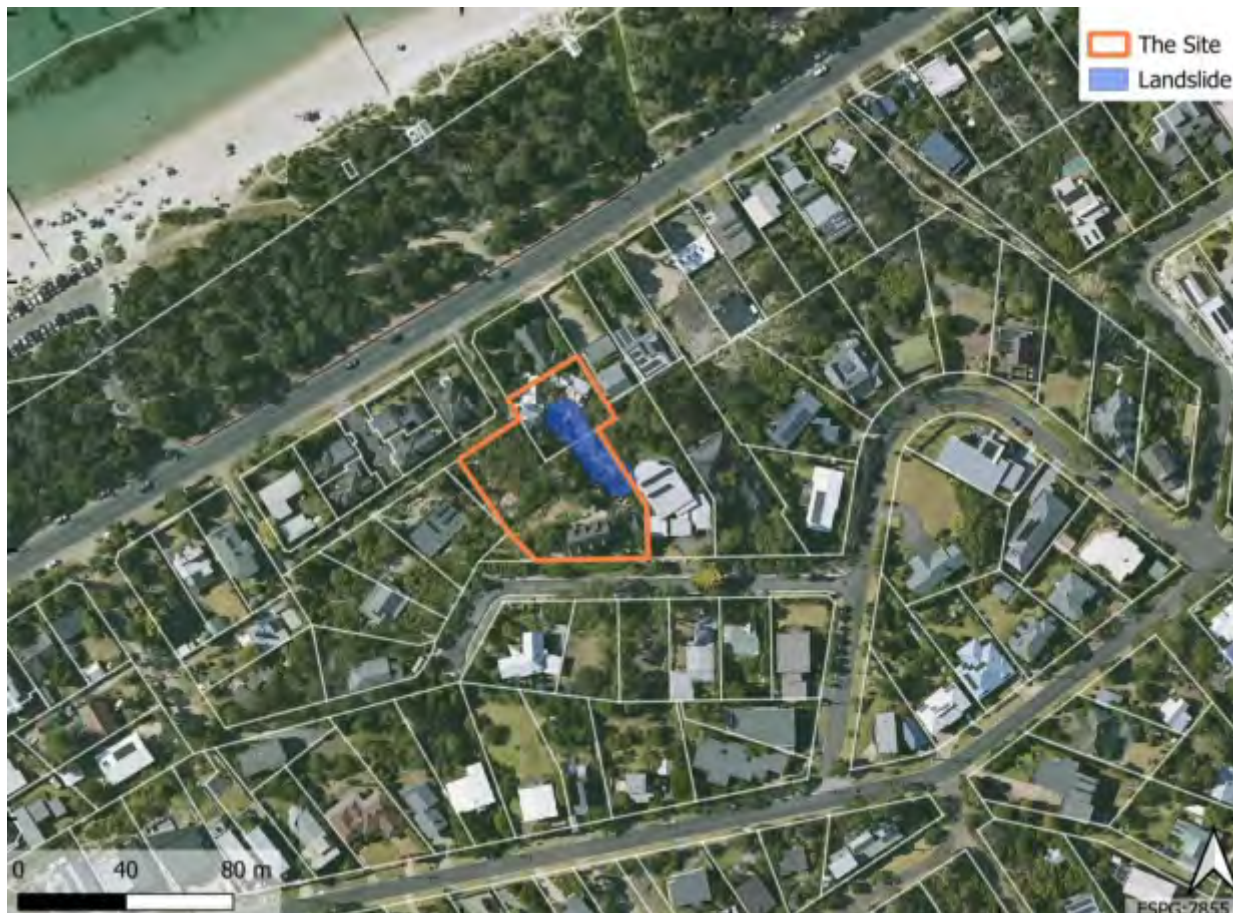
Figure 1: Annotated aerial photography showing the approximate location of the landslide and delineation of the Site (source: MetroMap; 2025-02-01. Annotation of site location added by SMEC)

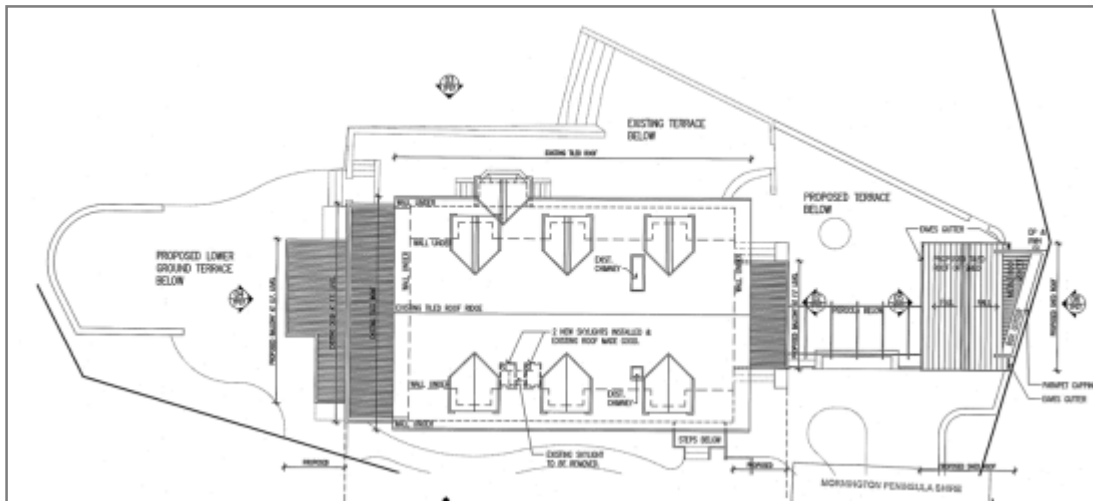
**2015 to 2016** – applications were submitted for 10-12 View Point Road comprising alterations to the existing dwelling, extensions, a new outbuilding, retaining walls, hard paving, fences and gates. The submitted plan of the proposed alterations is presented in Figure 12. This plan indicates that new terraces were proposed either side of the house, and a new structure was proposed on the northeastern side of the house. The plans indicate an extension to the terrace on the north-eastern side of the house, requiring the construction of new retaining walls and placement of fill at the crest of the escarpment in the area that the 2025 landslides subsequently occurred.

Figure 12: Plan of proposed development at 10-12 View Point Road (source: JDA Architects – Appendix B, Ref 16)

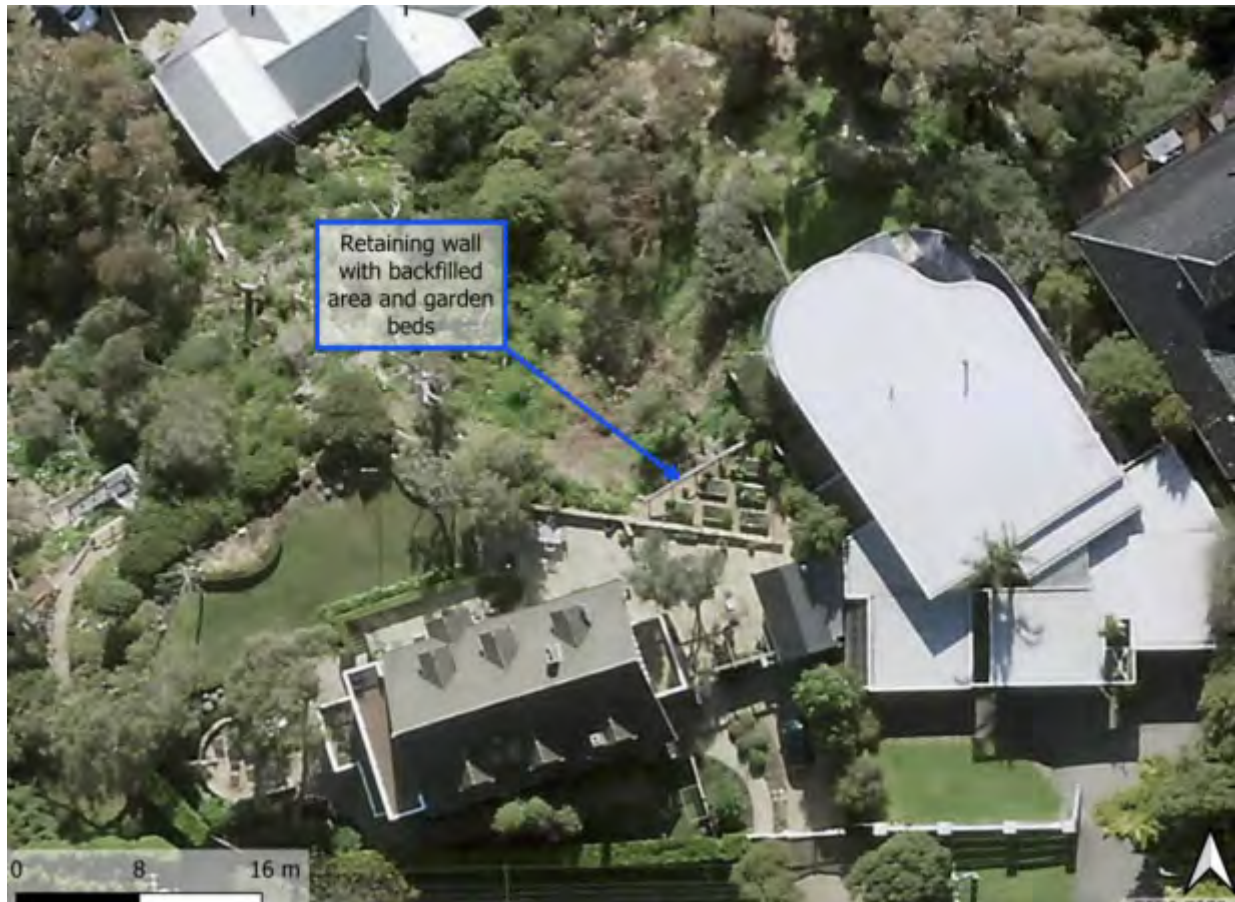
**2020 to 2021** – applications were submitted for the installation of a deck and engineered handrail for the edge of a garden. The planning application appears to have been withdrawn at the request of the property owner (Appendix B, Ref. 17). Aerial imagery from Metromap (refer Figure 14) and available photographs indicate that a post and timber panel retaining wall with backfill was completed prior to 30 December 2021 and raised garden beds installed on the backfill by 21 July 2022.

Figure 14: Aerial imagery of 10-12 View Point Road from 21 July 2022 (source: MetroMap accessed on 5 July 2025. Annotation added by SMEC)

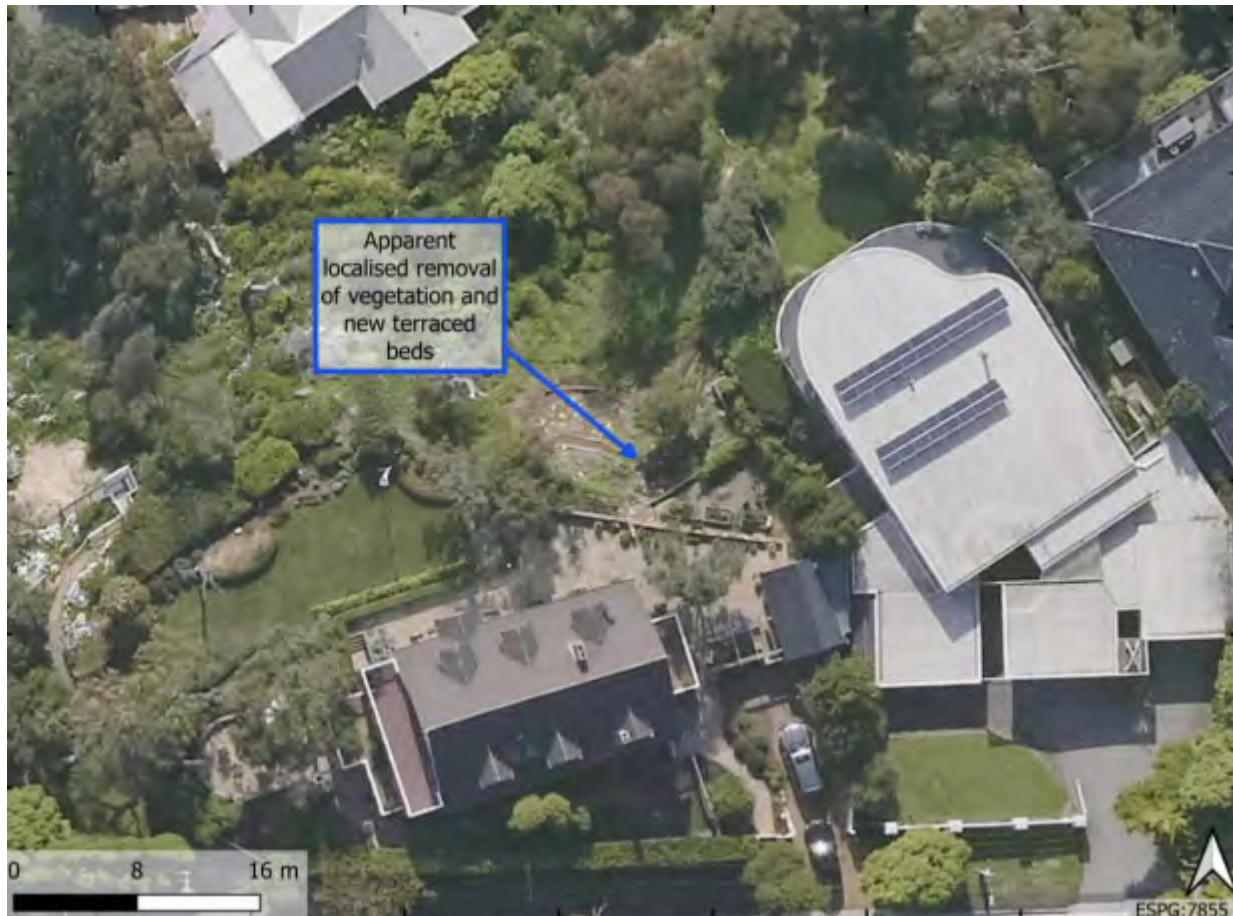
**Late 2022** – A steel post and timber plank retaining wall, understood from discussions with Mr. Borghesi during SMEC’s site visit of 17 June 2025 (Appendix C) estimated to be up to 900 mm high was constructed, to create a flat area for raised vegetable garden beds behind and across the slope (refer Figure 15). Some fill would have been required to infill behind the wall (Appendix B, Ref 25).

Figure 15: Aerial imagery of 10-12 View Point Road from August 2023 (source: MetroMap accessed on 5 July 2025. Annotation added by SMEC)

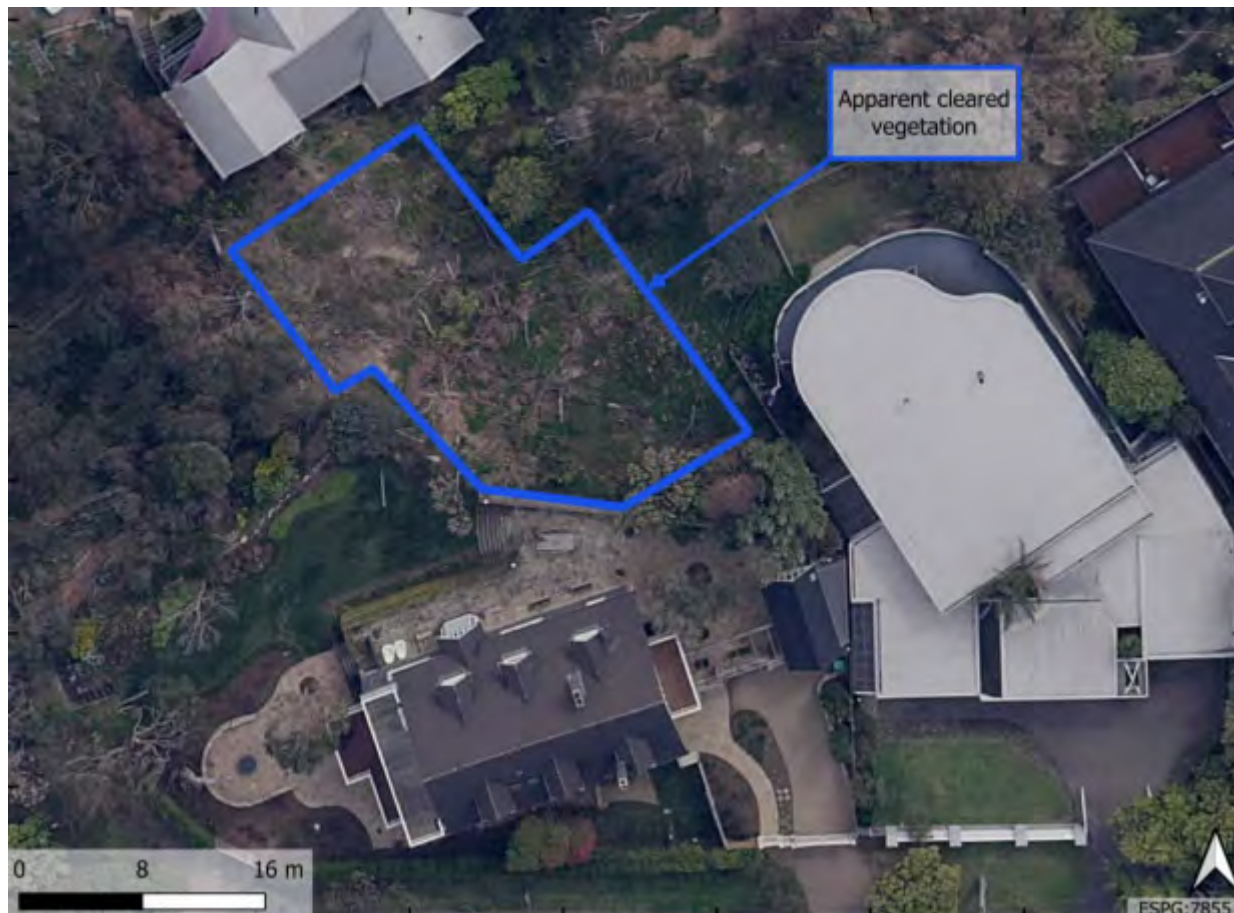
These observations indicate that there have been various instances of vegetation clearing at the Site between 2017 and 2023, including within the area that the 2025 landslide occurred. However, we are not aware of any evidence of significant changes between 2023 and the landslides in 2025. An example of an aerial image indicating removal of vegetation in 2018 is presented in Figure 16.

Figure 16: Aerial imagery of 10-12 View Point Road from September 2018 (source: MetroMap accessed on 5 July 2025. Annotation of vegetation clearing added by SMEC)

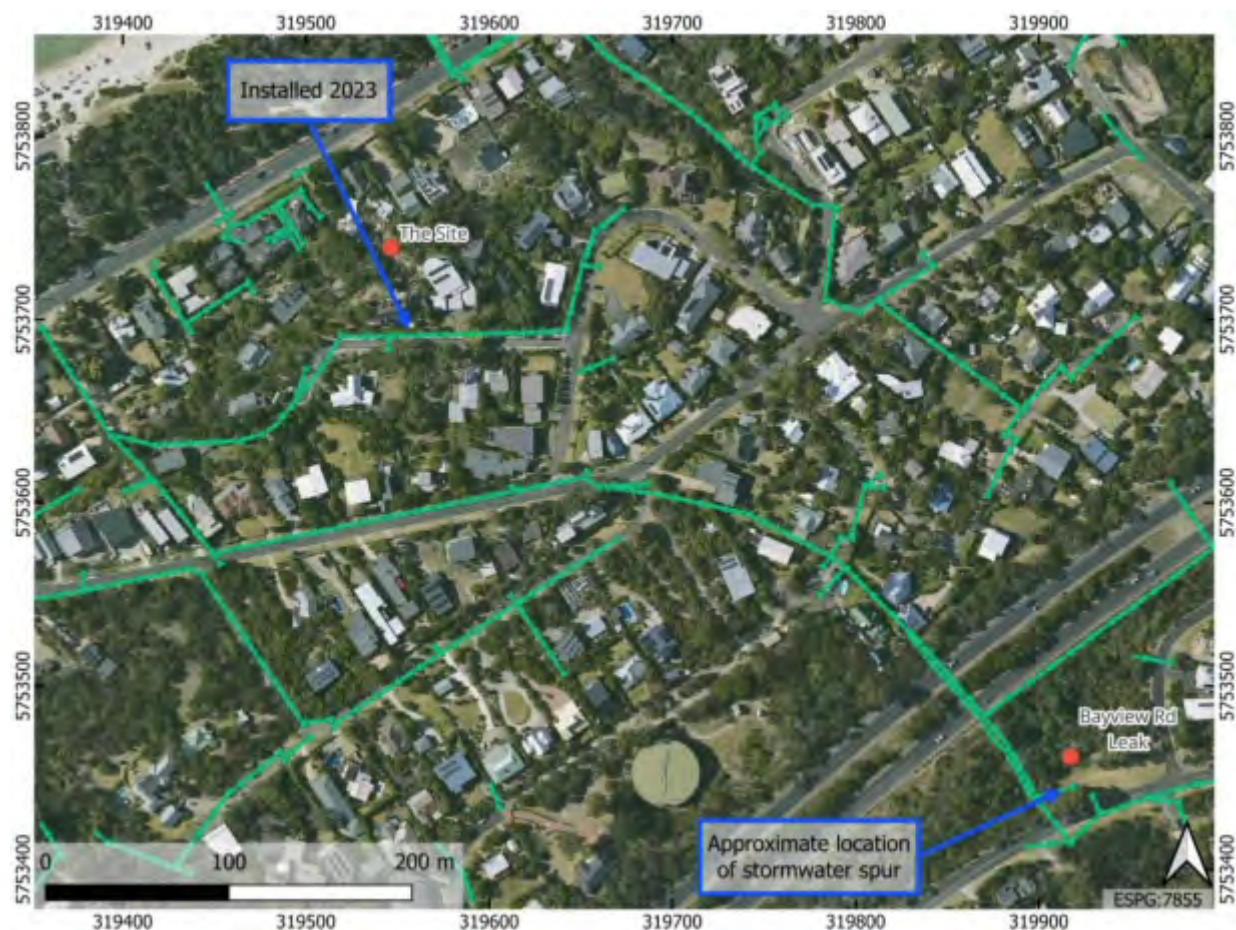
A plan of the stormwater network is presented in Figure 21. This plan has been annotated by SMEC to show the approximate location of known buried stormwater drainage that was installed along View Point Road in 2023. This figure is derived from Before You Dig Australia (BYDA) maps, which have been acknowledged to be incorrect by MPSC. No as-built drawings or site records of these construction works were available to SMEC at the time of writing this report. Based on conversations with MPSC, SMEC understands that the stormwater drainage flows from the front of No.4 to No.22 View Point Road. Drainage is located around the bend of Prospect Hill Road which SMEC understands connects to the newly installed drain along View Point Road.

Based on a memo from SEW, dated 15 May 2025, a separate ‘spur’ of the stormwater drainage system was identified and confirmed with MPSC on 15 May 2025. This spur is also shown in Figure 21, located near the Bayview Leak site. Given the likelihood that the construction of this spur is similar to other stormwater drainage lengths, it is reasonable to suggest that the embedment material of the spur comprises fine crushed rock or select fill. It is therefore reasonable to suggest that any perched water, or seepage from the Boulevard reserve may be in part, or in total be collected by the spur and the embedment material.

Figure 21: Map (not scaled) showing stormwater drainage network in the locality of the Site. Annotations have been added by SMEC of the stormwater drainage constructed in 2023 and known ‘spur’ confirmed by MPSC

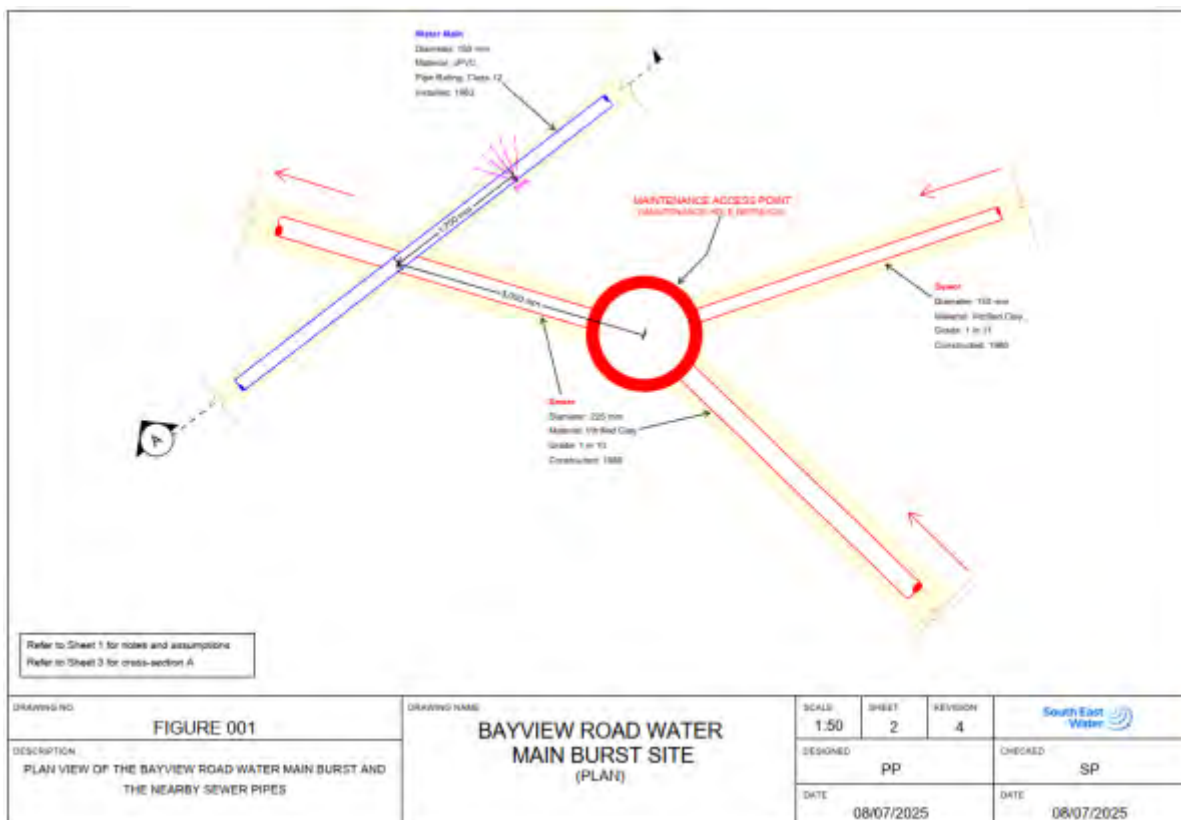
Figure 23, Figure 24 and Figure 25 have been produced by SEW to describe the vicinity of the Bayview Road leak, with particular emphasis on pipe embedment. The figures note that the sewer bedding material, according to the standard drawing of a previous sewerage authority, comprises a coarse aggregate. SEW has confirmed the embedment material in recent excavation works. Above this material, the embedment material comprises sand. The mains pipe crossing over the sewerage also comprises sand embedment material.

Figure 24: Plan view of Bayview Road water main burst &amp; nearby sewer pipes

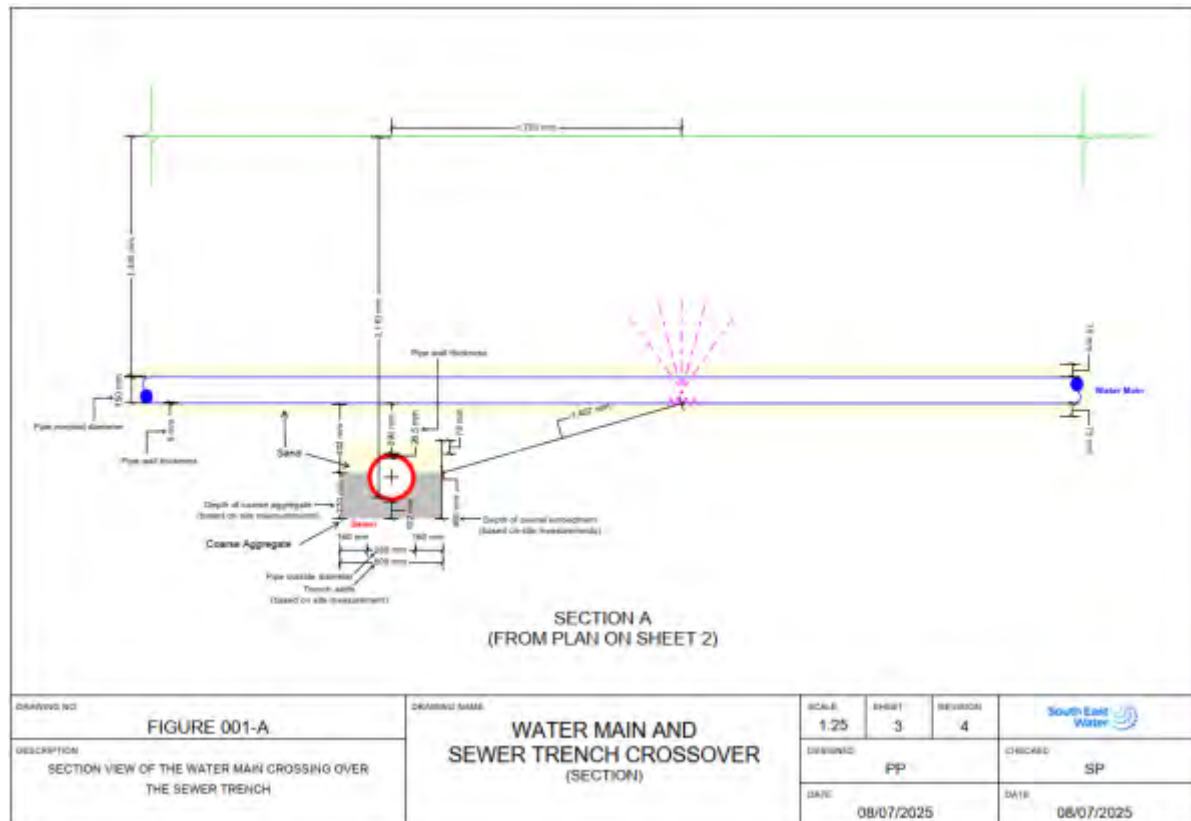
Figure 25: Section view of the Bayview Road water main crossing over sewer trench

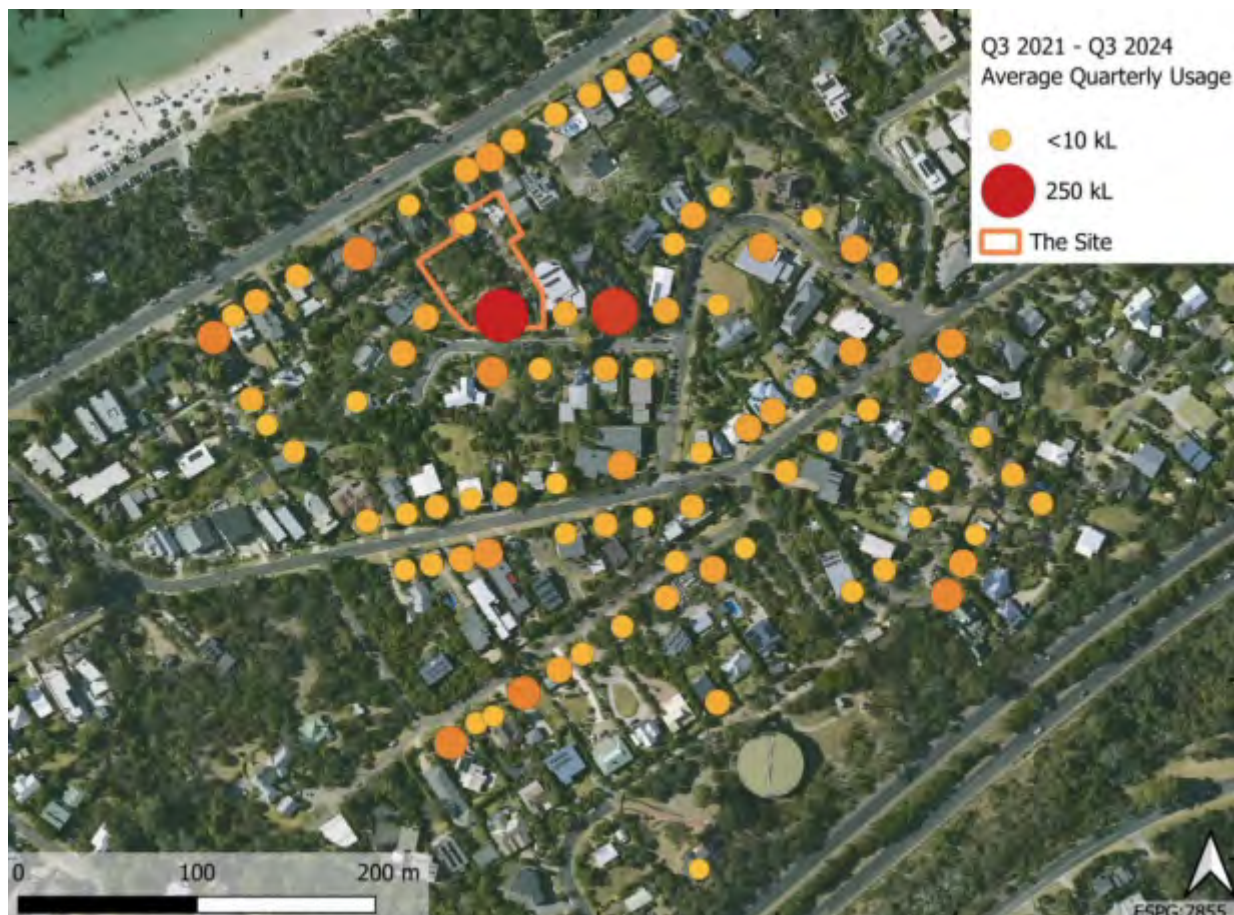
Figure 26: Private water usage of properties in the vicinity of the Site

Water usage of Nos 4 and -12 View Point Road is greater than the area average for permanent occupancy for all quarters since Q3 2021, up to, and including, Q4 2024. It was noted during the SMEC site visits, that there was a substantial irrigation system within the gardens of No. 10-12 View Point Road. SEW water understands that No. 4 View Point Road has an irrigation system installed.

No extensive examination has been carried out, of whether properties assessed as permanently occupied, also have irrigation systems. However, it is reasonable to conclude that the irrigation systems of both Nos. 4 and 10-12 View Point Road to have at least maintained moisture content in the properties at a higher level than surrounding properties without these systems. It is possible that near surface waterflow, and slope stability may have been affected by the usage of the systems.

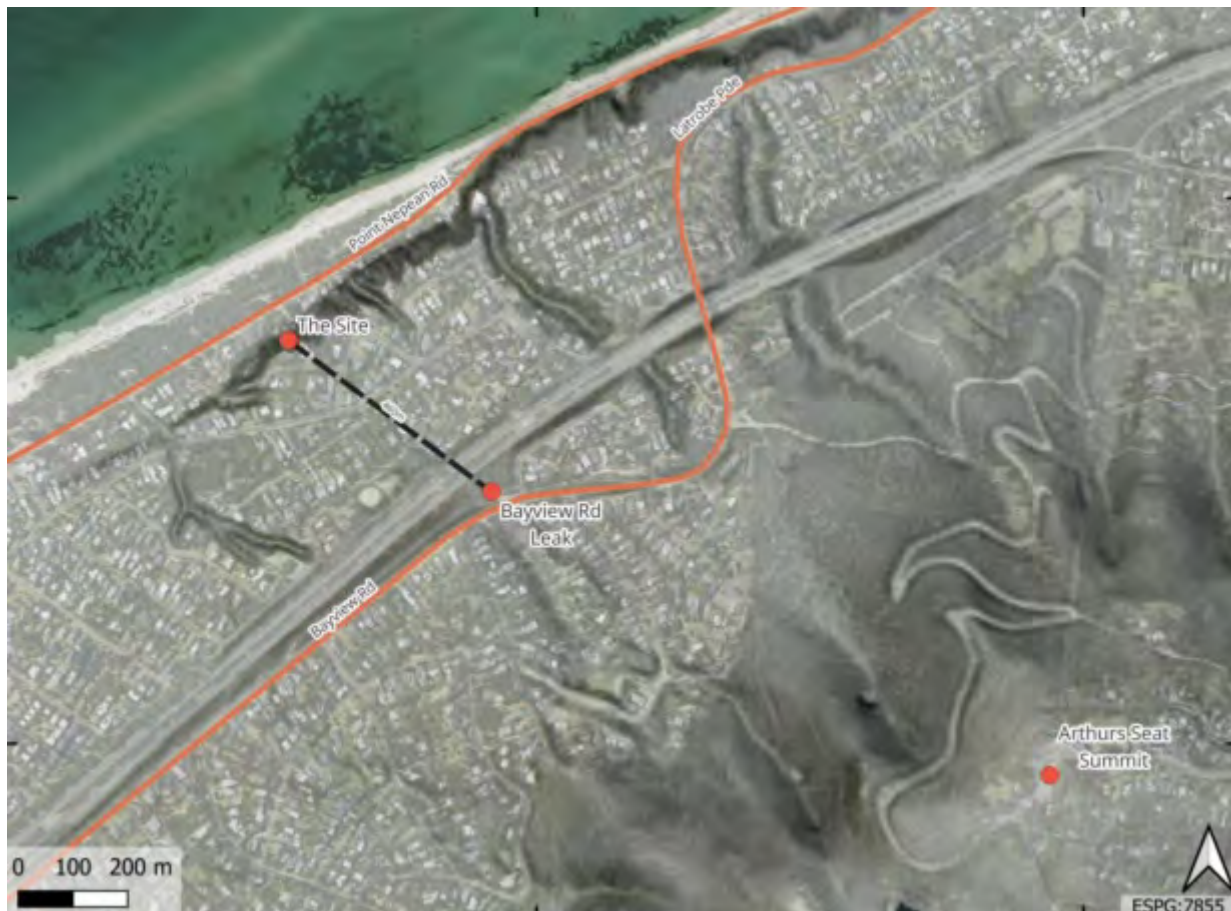
Numerous witness statements and SEW’s own records detail a leak that occurred due to a fracture within a PVC water pipe near Bayview Road, approximately 450 m, south and upslope from the Site. SEW has advised that the fracture was located on 30 December 2024 and repaired on 1 January 2025. The date that the water leak began is thought to be in early August 2024 according to a report from the University of Auckland (Appendix B Ref. 40) . Residents began to report potential leaks at Charlesworth Street and Waller Place between 26 November 2024 and 1 January 2025. The University of Auckland report estimated, based on SEW raw data, that the volume of water that may have been lost through the leak was 40.3 ML .

Figure 27: Plan showing the location of the water main leak at Bayview Road in relation to the Site

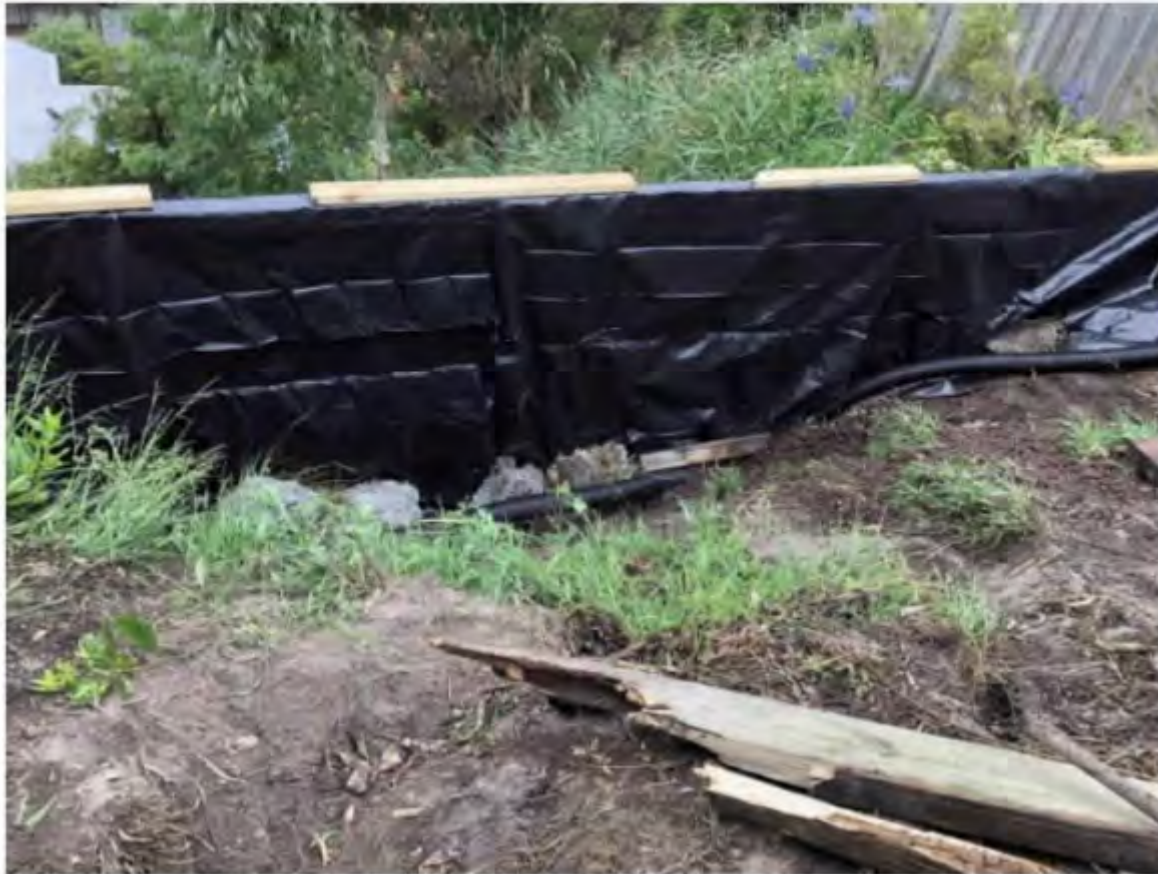
### GB-12 Retaining Wall

The landowners showed SMEC personnel a photograph taken before the retaining walls were constructed. The photograph showed a slightly sloping ground, dipping from the View Point Road (behind the photographer), to the crest of the escarpment. Figure 1 is a copy of GB-12, a photograph submitted as part of the annexure to the witness statement to the inquiry of Mr. Borghesi (Appendix B, Ref 25) . This figure shows the slope of the ground behind the original retaining wall, during construction works. The grassed topsoil, may be the material exposed by the backscarp of the McCrae landslide.

Figure 1: GB-12, taken from Annexure of Witness Statement of G Borghesi, showing construction of original retaining wall,

The original retaining wall constructed of post and wooden sleepers, with tie backs comprising steel rods, with H-Section (assumed) into the natural material. The landowners described how the wall abutted the naturally steep gradient of the upper slopes of the escarpment. Forming a straight, or 'engineered' edge to the gently sloping surface behind the crest. It was noted on site that this surface, now paved, was approximately level.

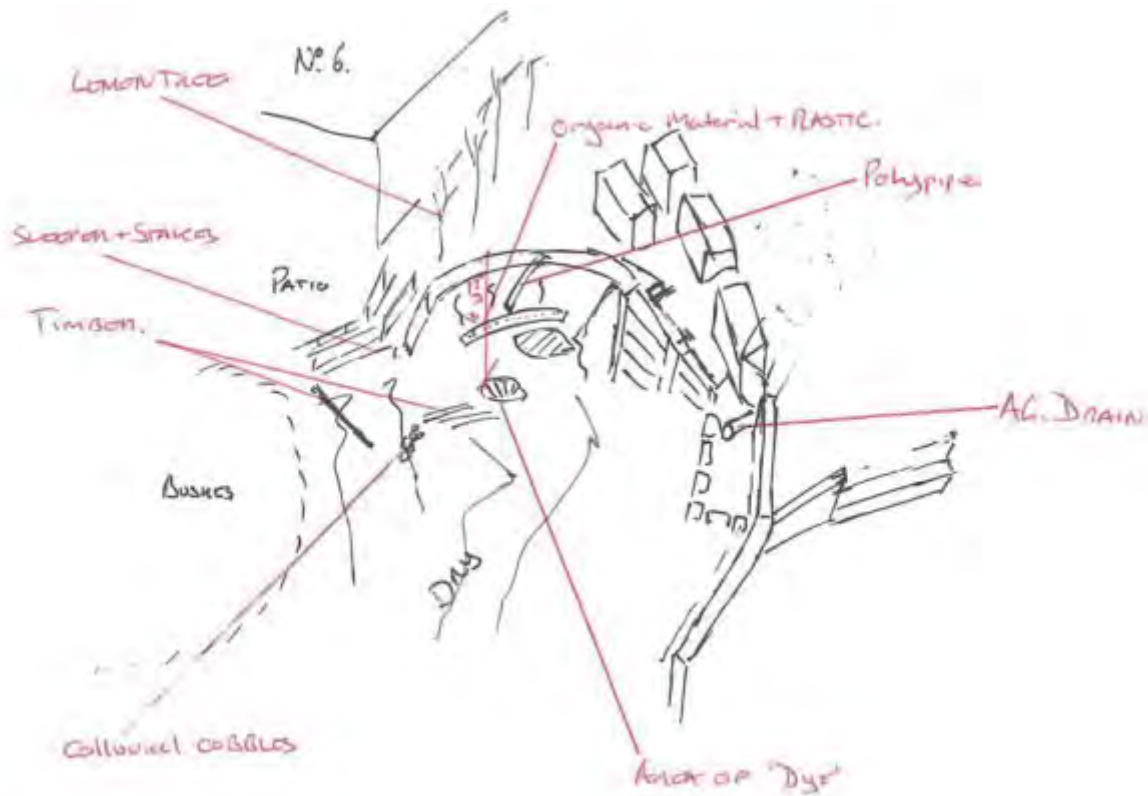
Figure 2: Sketch showing features noted by SMEC of the McCrae Landslip, from vantage points within 10-12 View Point Road property extents.

The owners of 10-12 View Point Road hypothesise that the remnant head of the gully used to head east, below the lemon tree (Figure 4).

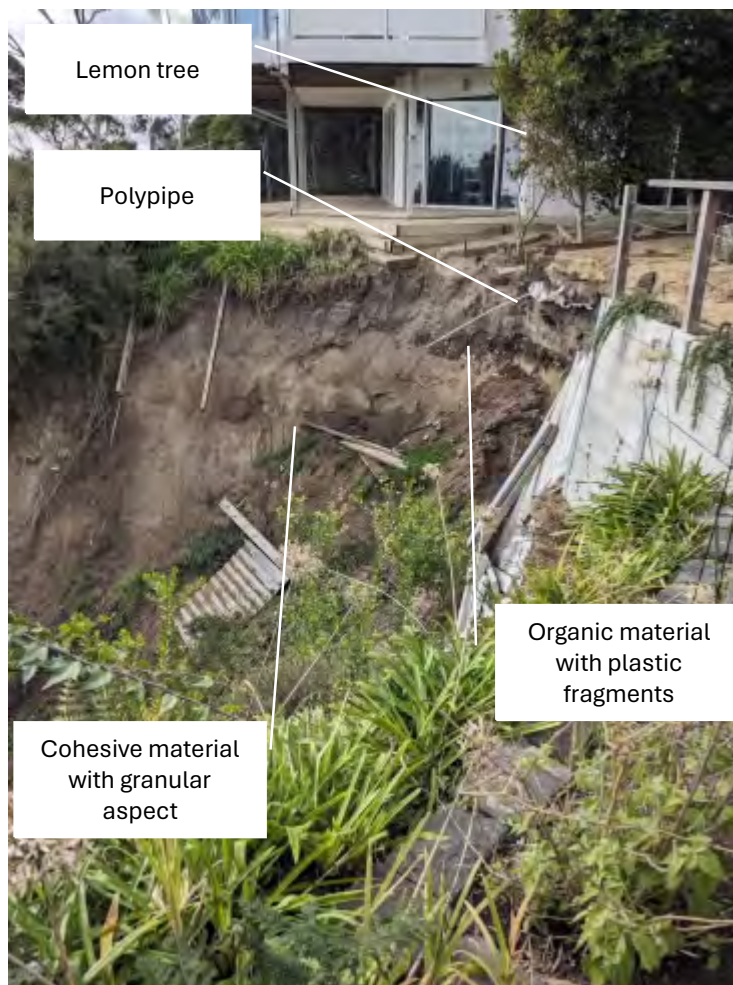
Figure 4: 17/6/25 Photo 01 Looking east showing the detail of the backscarp. Note the vertical nature of the backscarp, approximately 4.5m high.

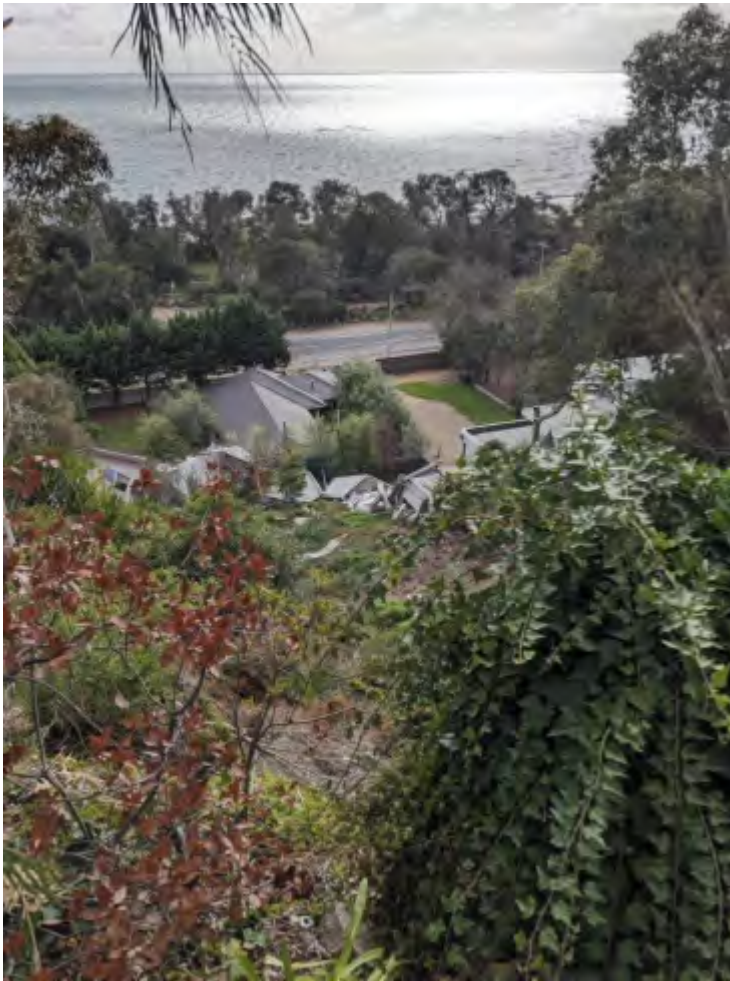
Figure 5: 17/6/25 Photo 02 Looking north showing the extent of landslide

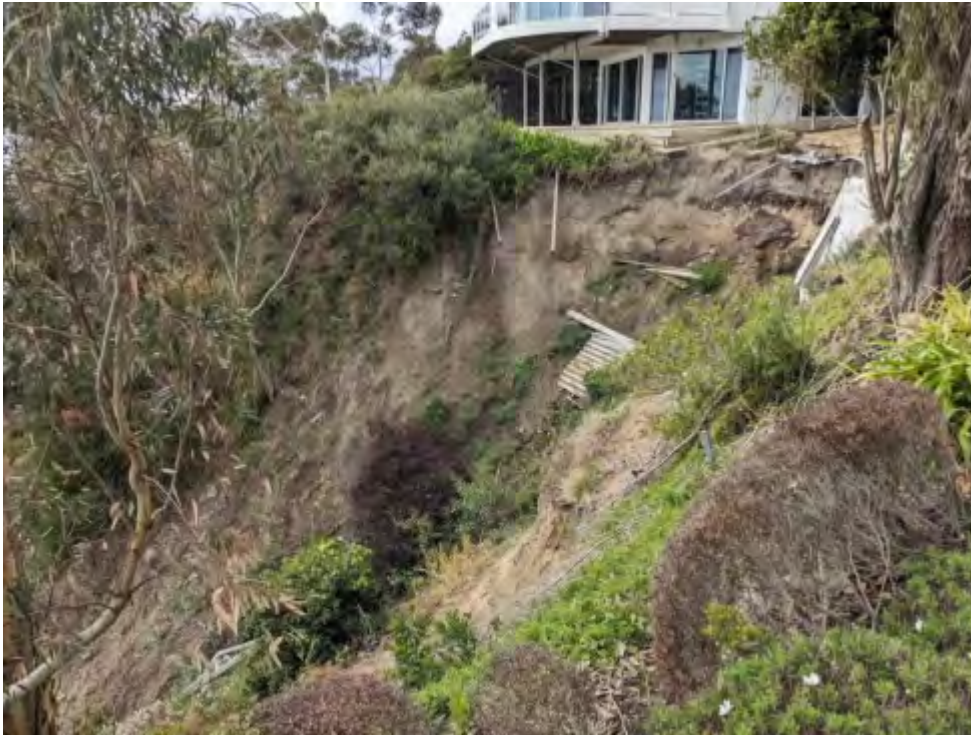
Figure 8: 17/6/25 Photo 04 Looking east showing the detail of the backscarp. Note the vertical nature of the backscarp, approximately 4.5m high

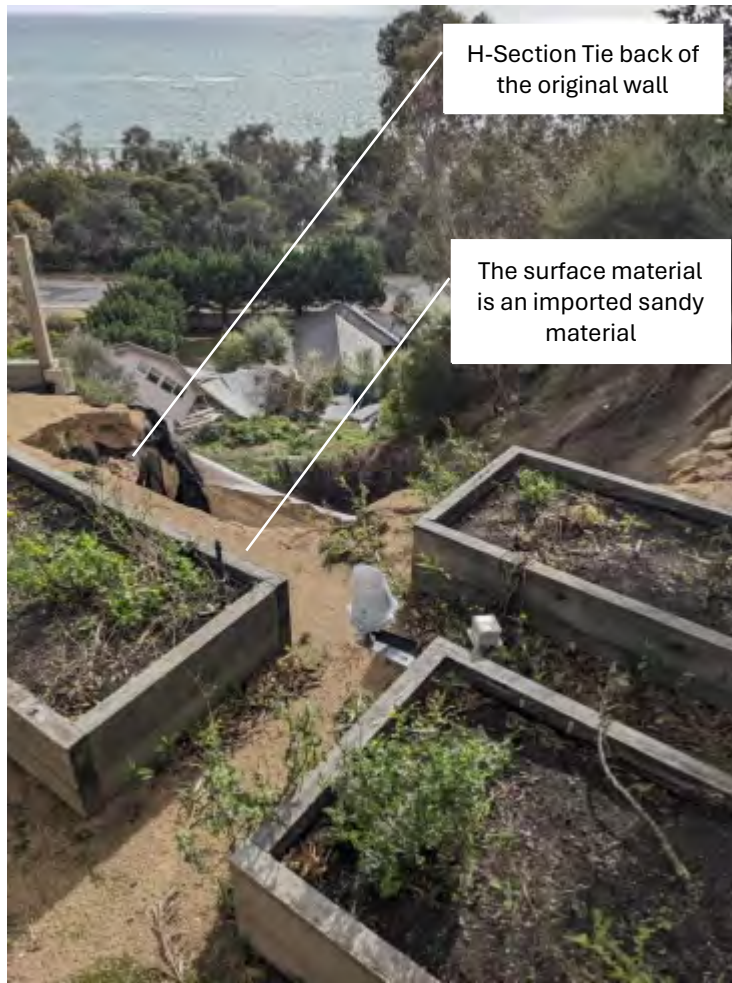
Figure 9: 17/6/25 Photo 06 Looking north from behind the raised vegetable patch, towards the toe debris of the landslide. The tie back of the original retaining wall is visible, as is the white geofabric of the drainage measures of the 'aesthetic' wall

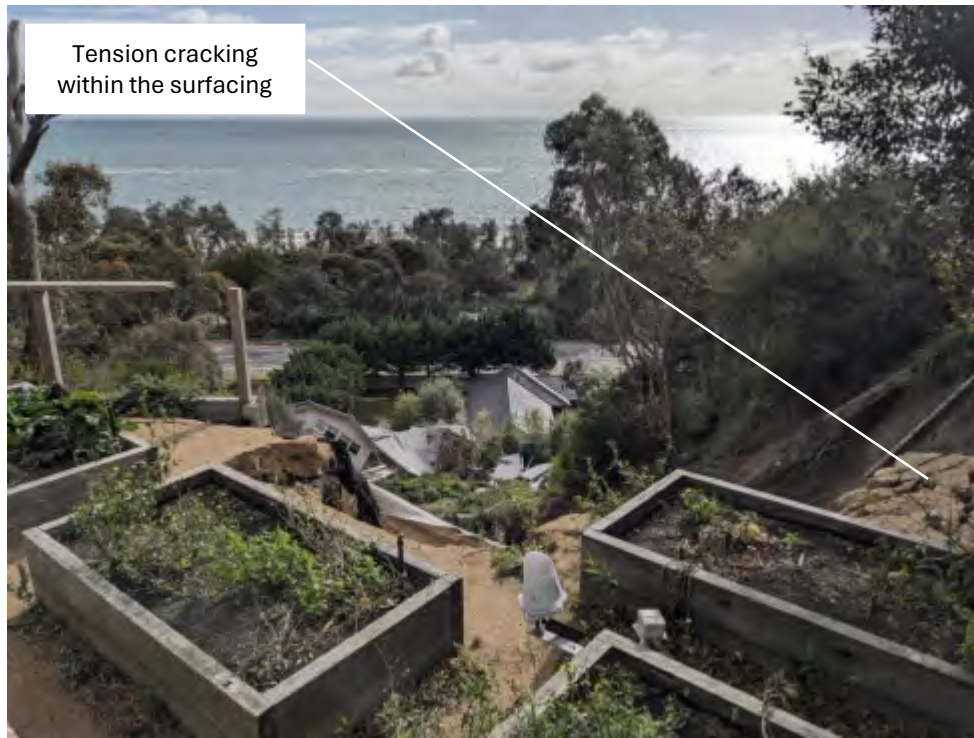
Figure 10: 17/6/25 Photo 07 Looking north, down the direction of the landslide

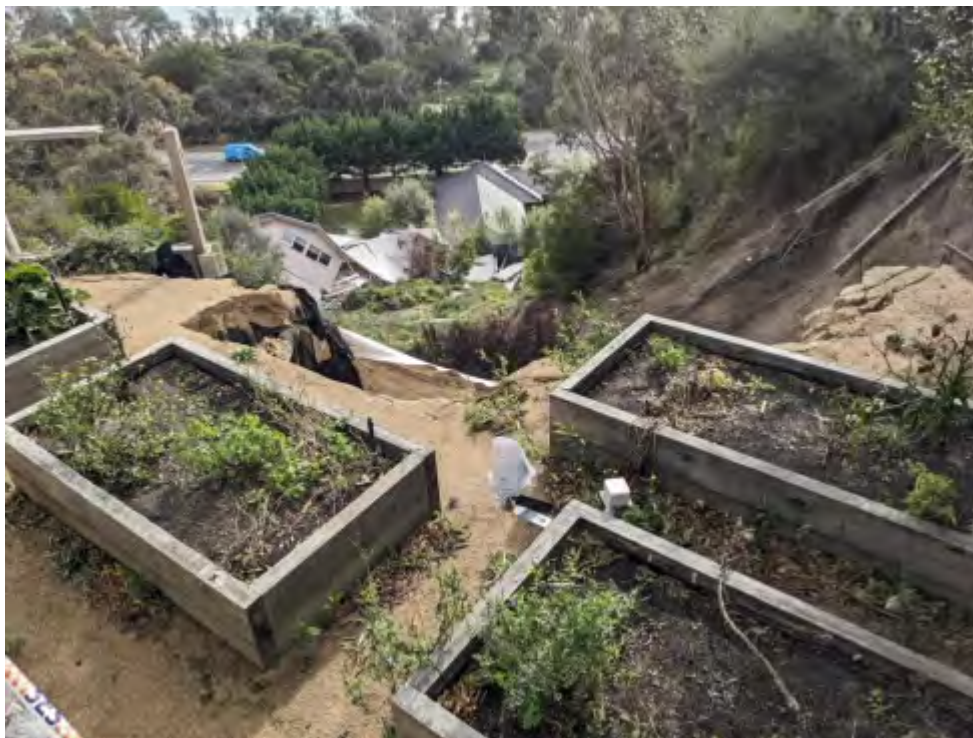
Figure 11: 17/6/25 Photo 08 Looking north over the vegetable garden, showing the crest of the backscarp

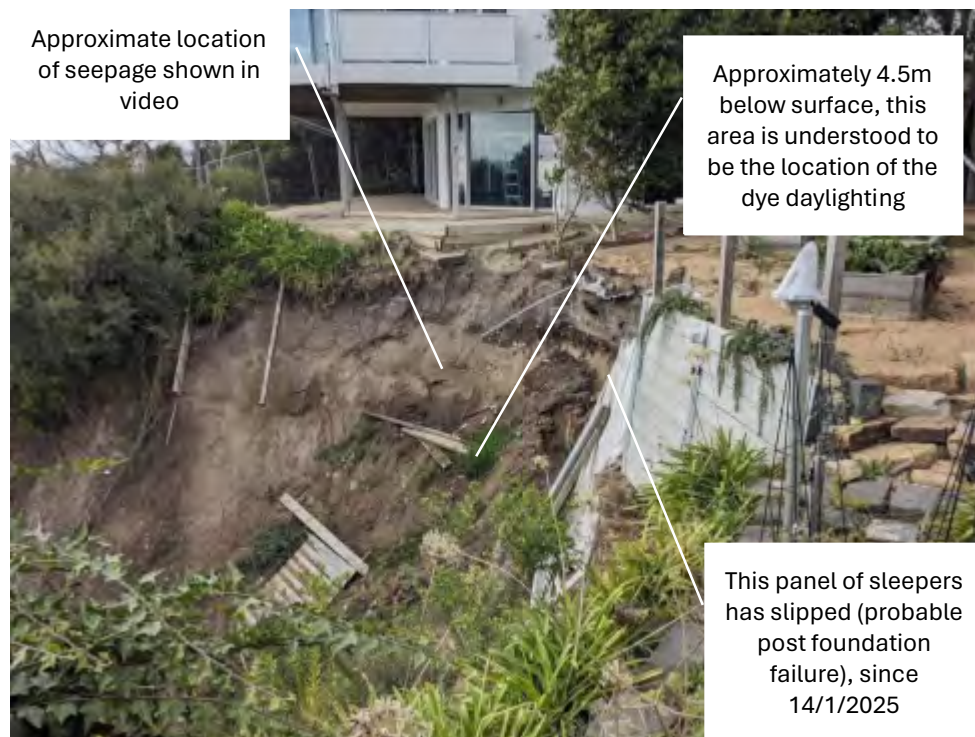
Figure 12: 17/6/25 Photo 09 Looking east showing the location of the seepage videoed by the landowners on 14 January 2025, and location of the dye that was seen daylighting through the backscarp after dye was poured into NDT01/02.

Figure 12 should be compared with Figure 13, which shows three panels of sleepers of the retaining wall still standing.

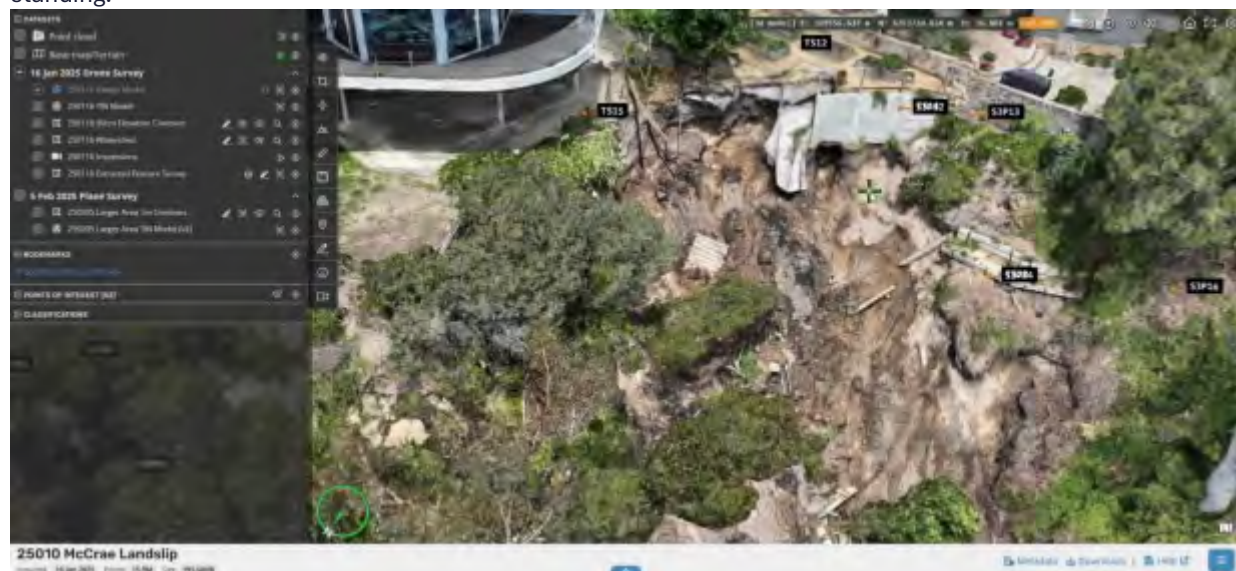
Figure 13: Detail of the landslide drone footage taken on 15/1/25.

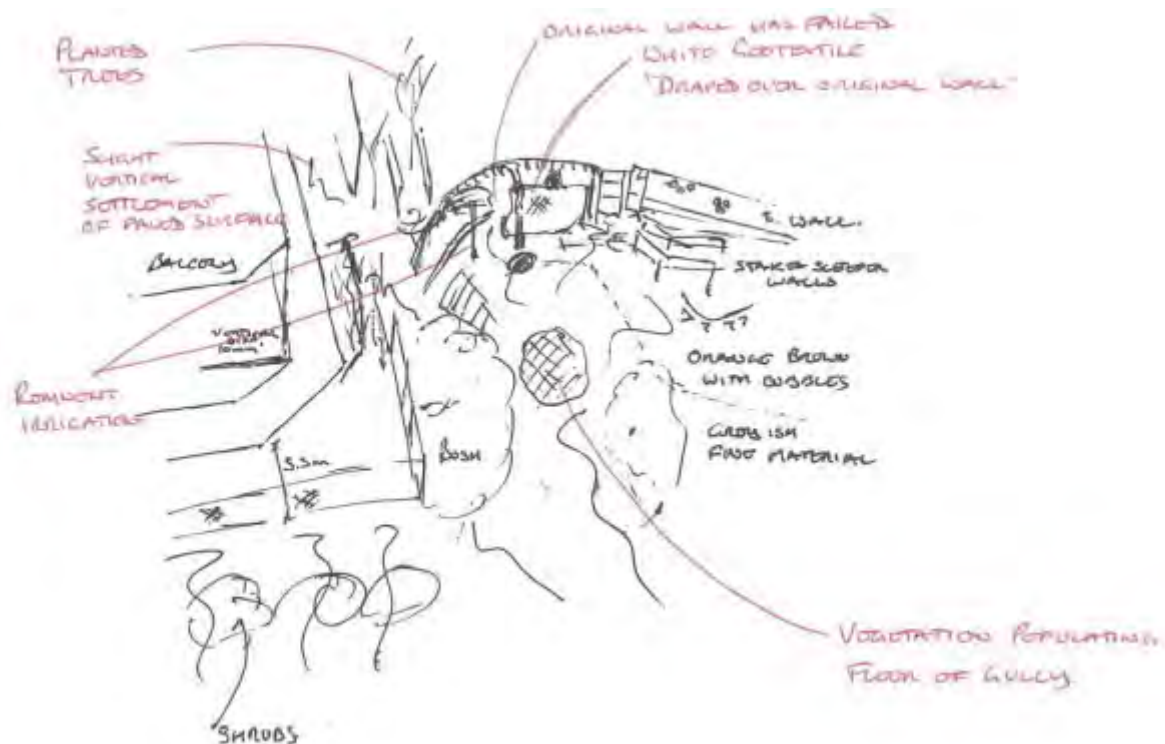
The exposed geology seemed to comprise a granular matrix with cobbles, overlying a greyish sandy material. The Council Building Surveyor pointed out suspected areas of ‘piping’ within the backscarp to SMEC personnel. The cause and exact nature of these areas were not confirmed by SMEC Engineers on site. Assessment of the dispersive nature of local geology is part of the scope of the SMEC intrusive investigation works, to be included in an addendum.

Figure 16: Sketch showing features noted by SMEC of the McCrae Landslip, from vantage points within 6 View Point Road property extents .

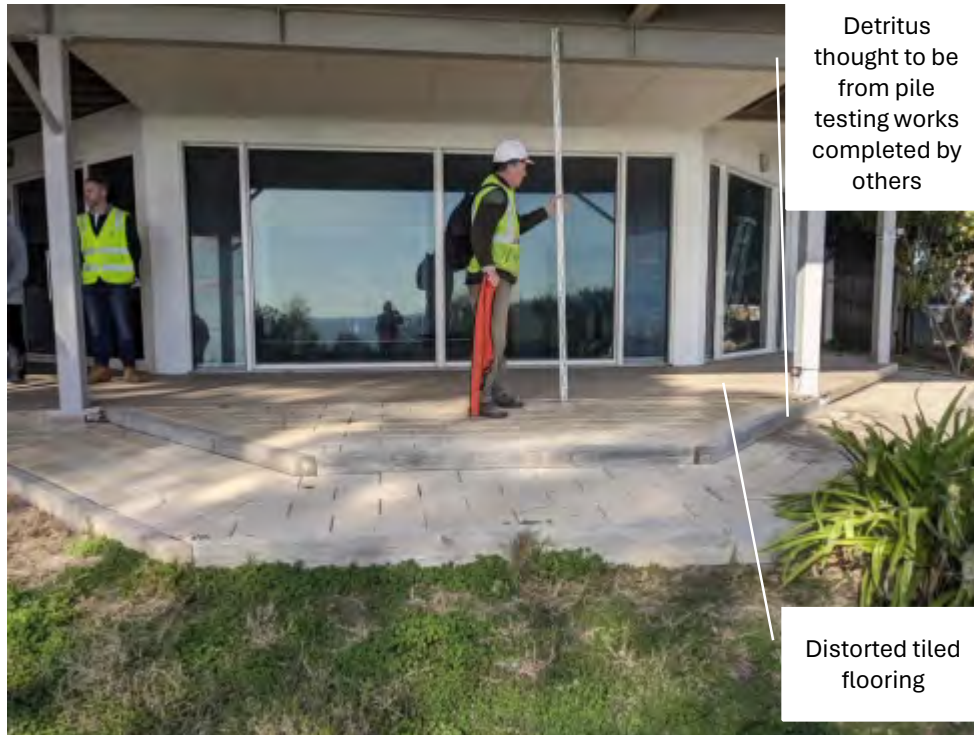
Figure 17: 20/6/25 6 View Point Road, looking south note the disturbed paving, but the house does not show signs of movement.
