Multidisciplinary Expert Supplementary Report

# Board of Inquiry into McCrae Landslide

Prepared for: Thomson Geer

21 July 2025

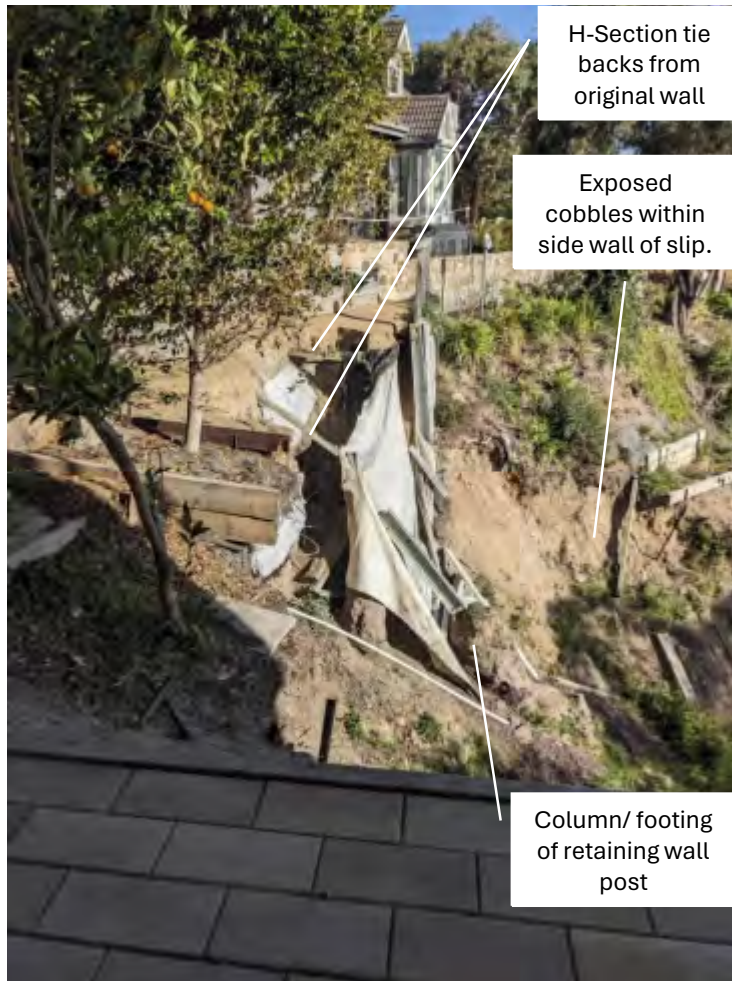
Figure 18: 20/6/25 6 View Point Road looking west along line of retaining walls, showing tie backs, and several irrigation pipes

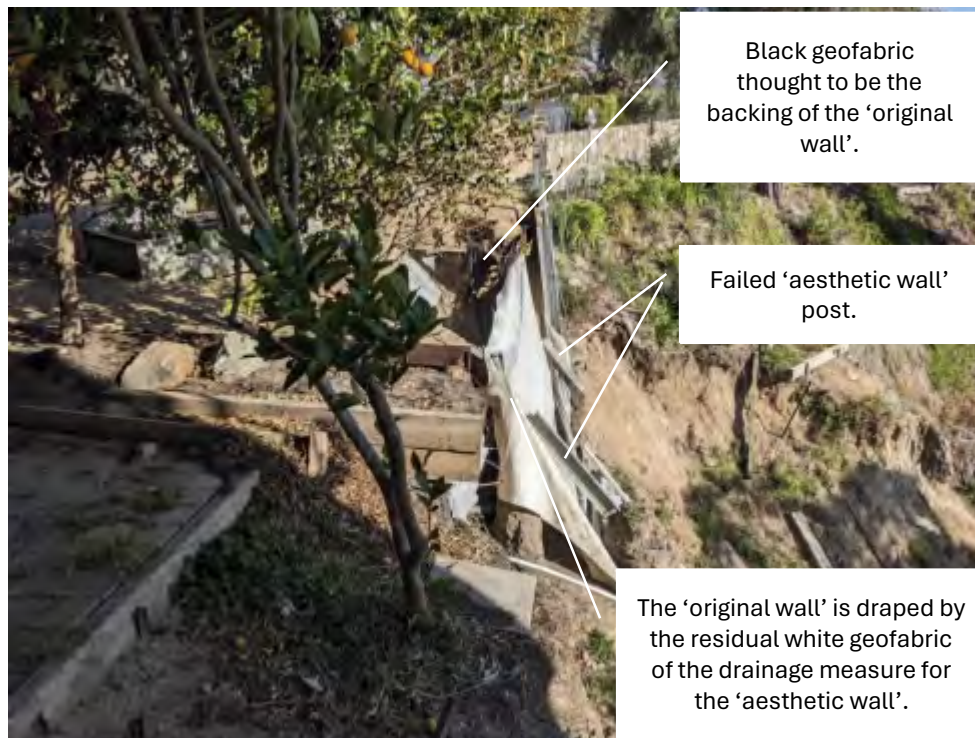
Figure 21: 20/6/25 looking west, showing lemo tree in the foreground, with colluvial material exposed in background.

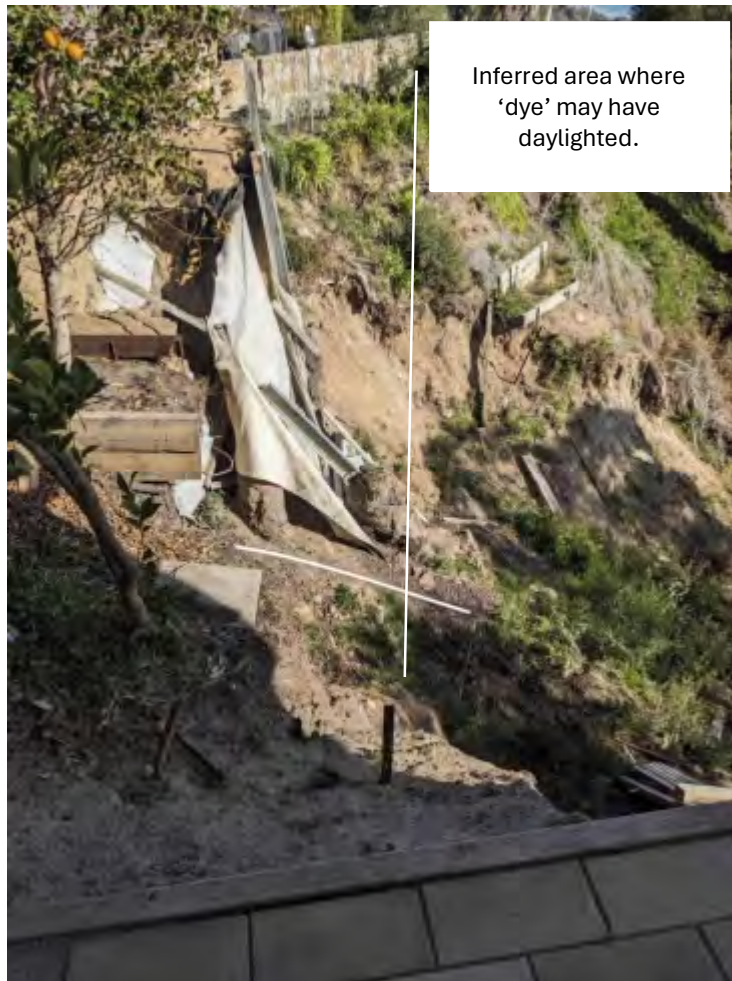
Figure 22: 20/6/25 looking west showing colluvial material exposed , note the geofabric behind the line of the retaining wall.

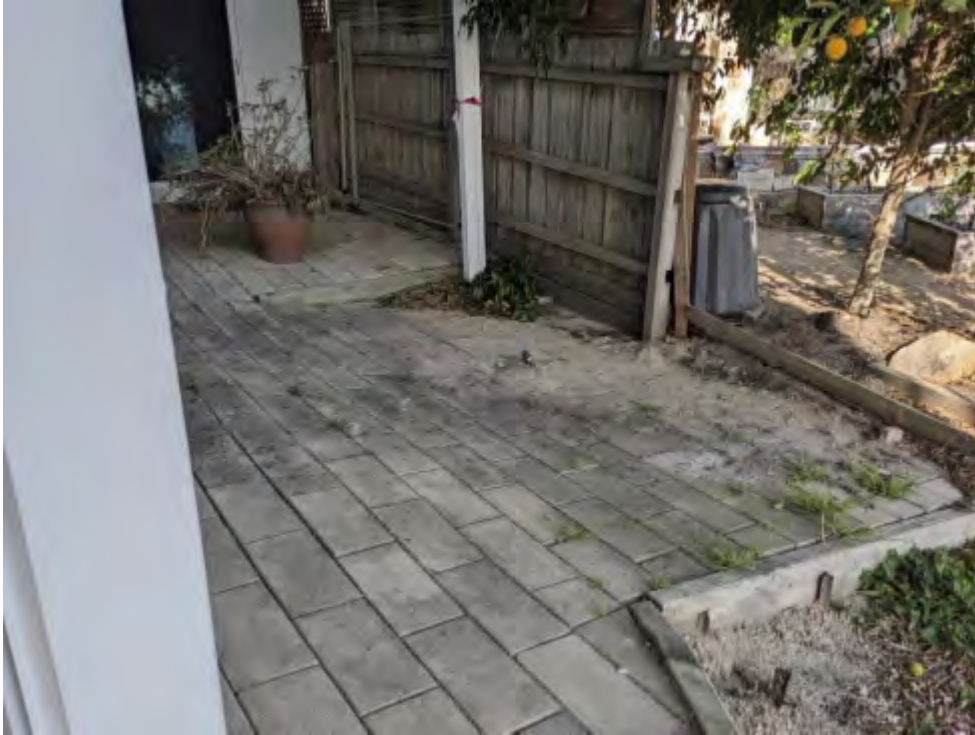
Figure 25: 20/6/25 6 View Point Road, looking south towards fencing with No. 10, showing disturbed ground.

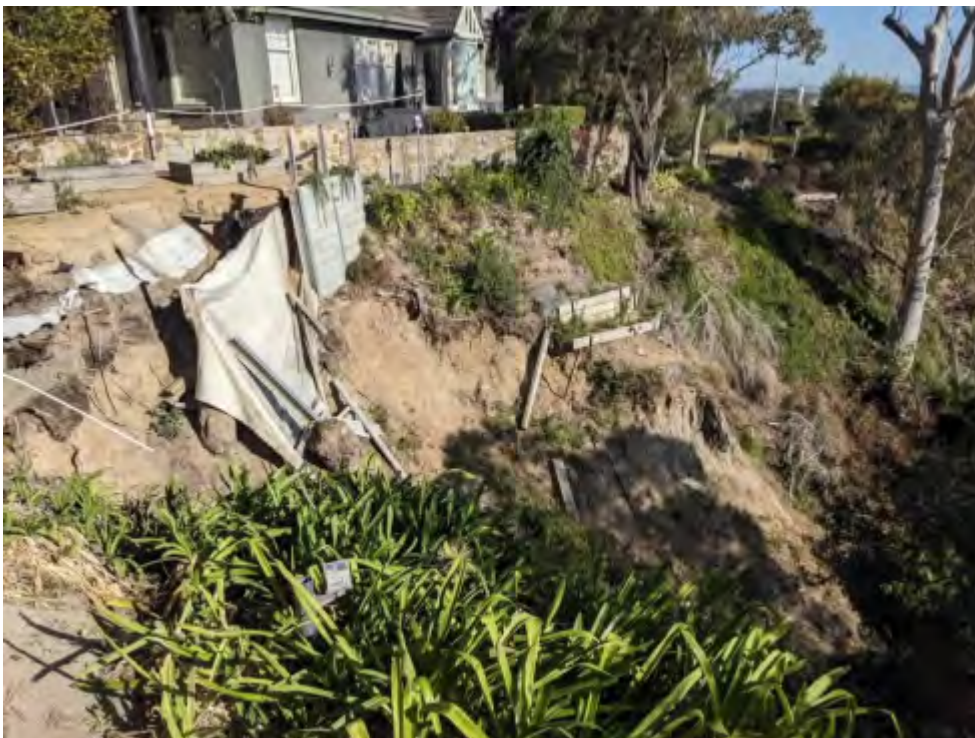
Figure 26: 20/6/25 Looking west from 6 View Point Road. Note the change in geology below the wooden sleepers.

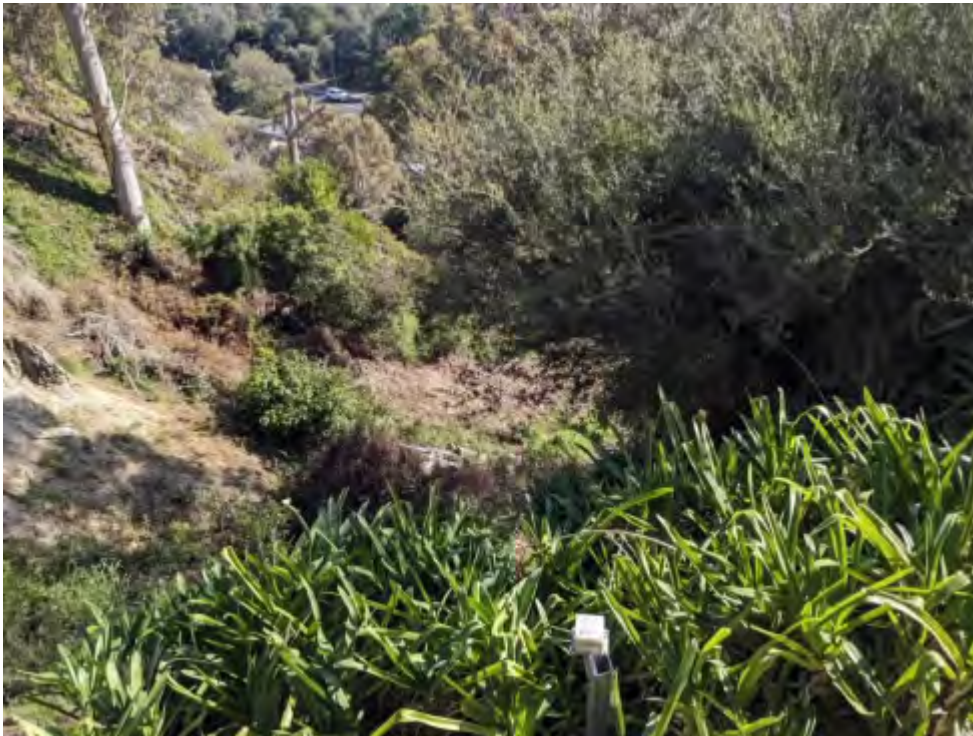
Figure 27: 20/6/25 6 View Point Road, showing evidence of vegetation growth.

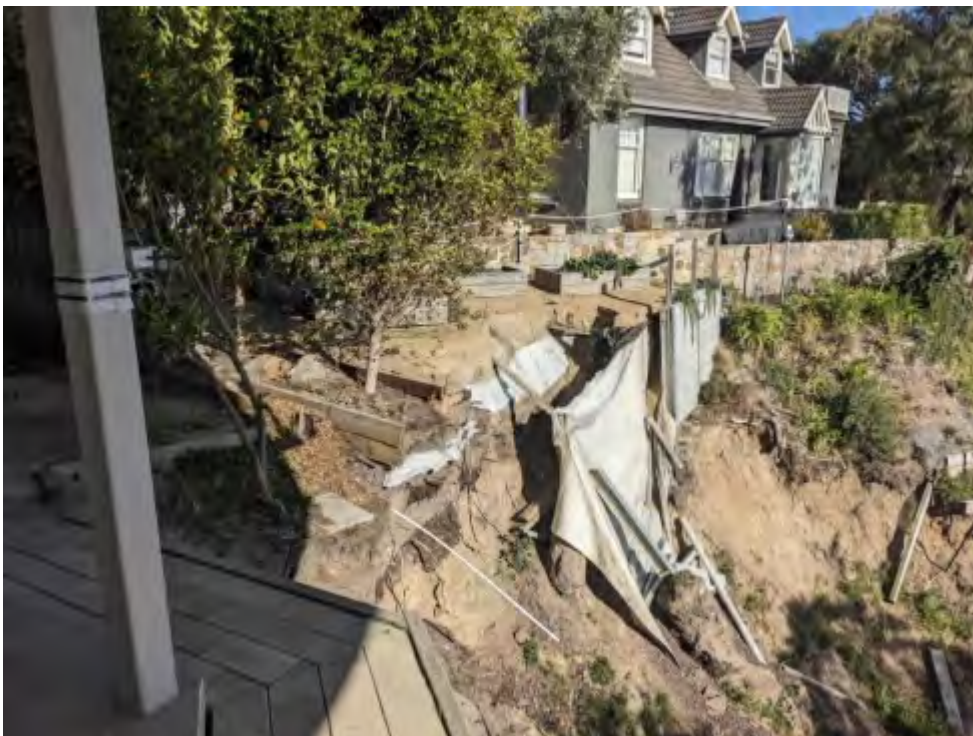
Figure 28: 20/6/25 6 View Point Road looking west. Note the leaning back of the retaining wall posts

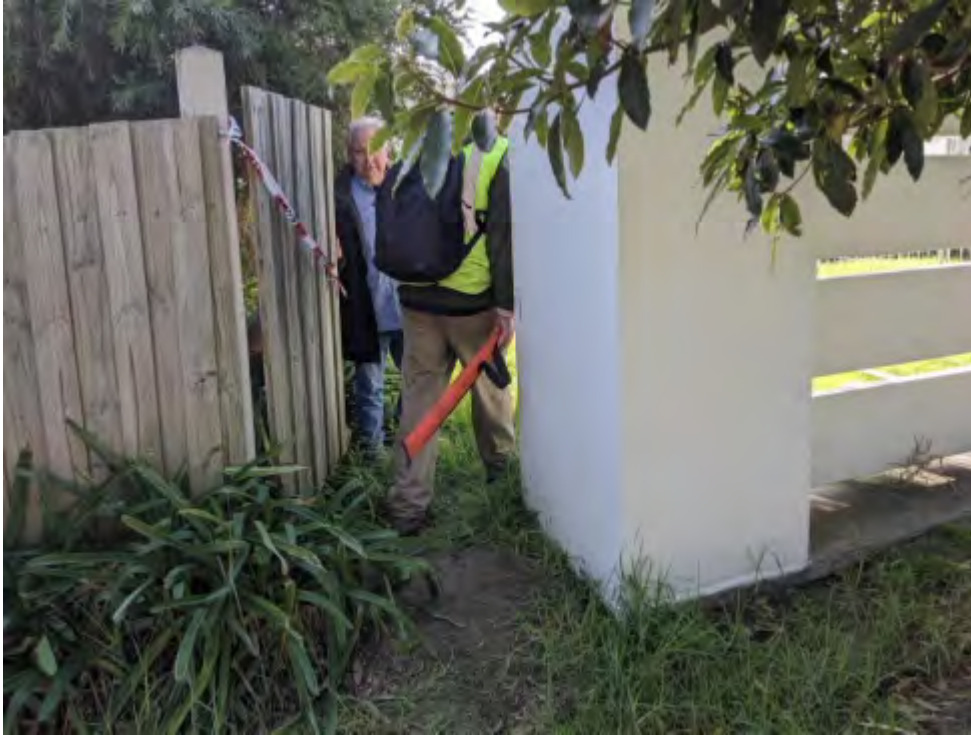
Figure 29: 20/6/25 6 View Point Road looking north showing front gate which has had to be shaved due to toppling concrete pillar.

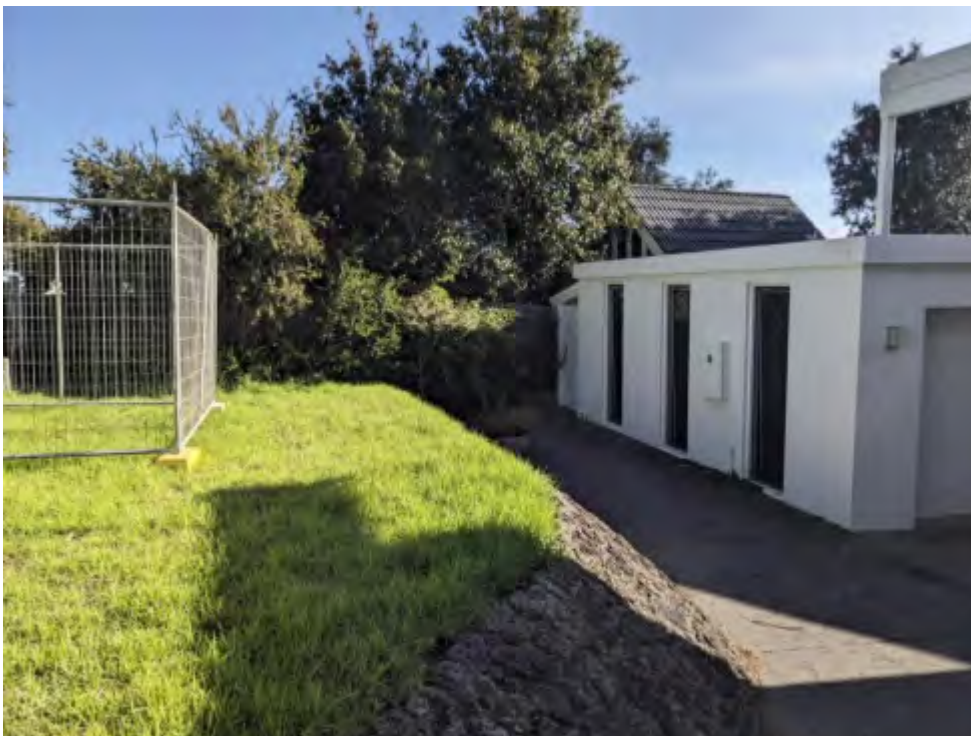
Figure 30: 20/6/25 6 View Point Road, Front Garden looking west showing platform 1m high where NDT 01 was drilled.

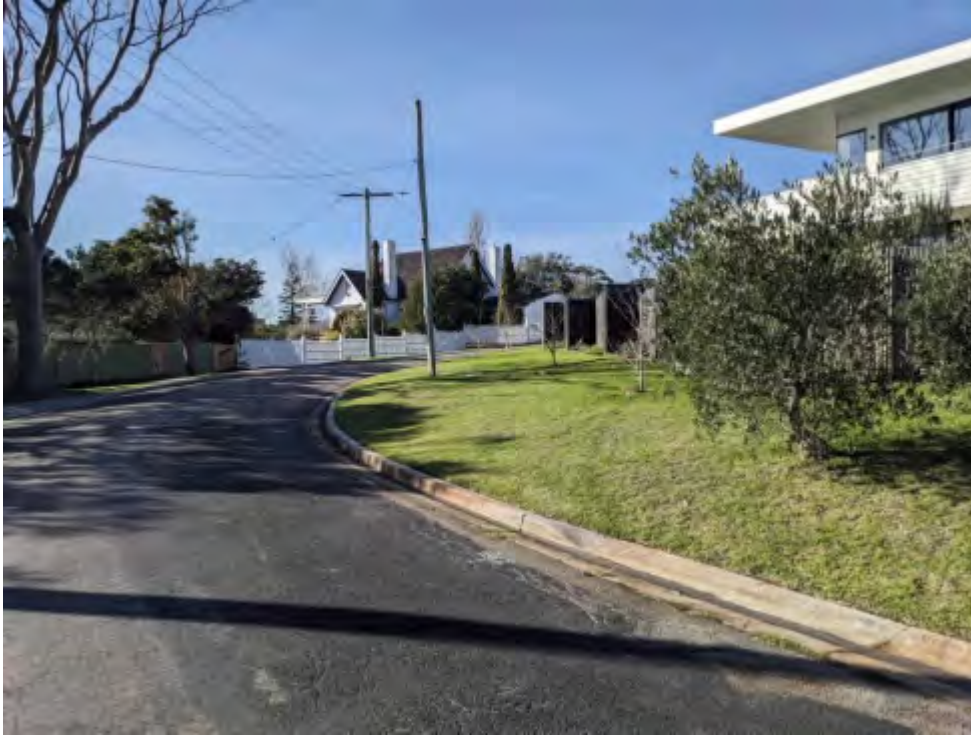
Figure 33: 20/6/25 7 Prospect Hill Road, looking east showing verge

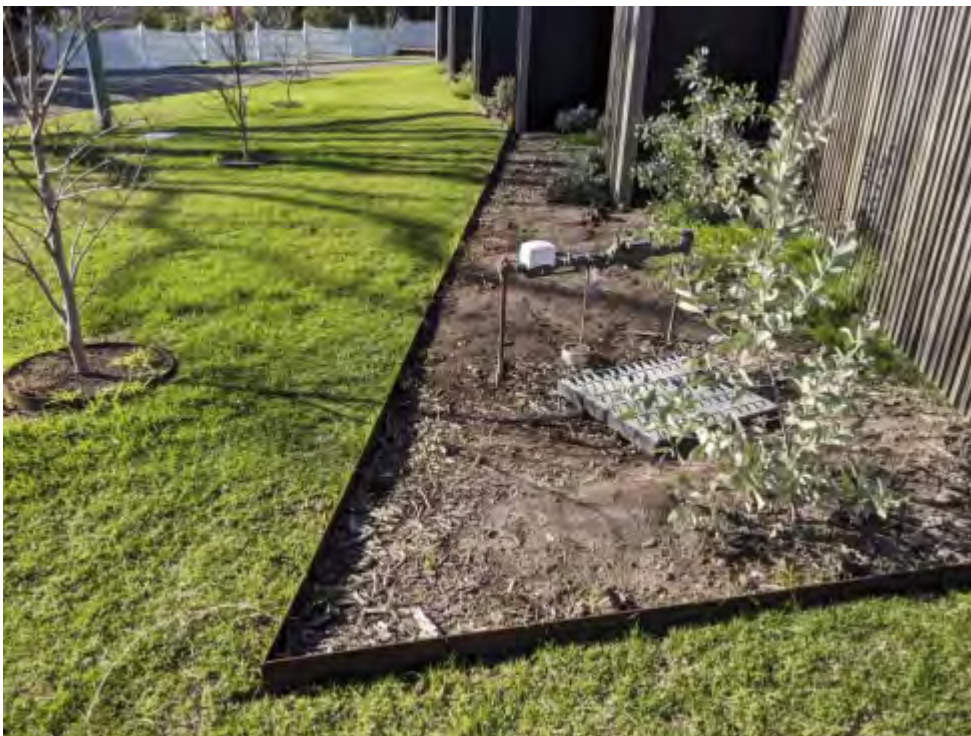
SMEC personnel observed a private gully pit, known to be the collection point of the AG drainage system for No. 7, recently rebuilt. This gully drains in to the stormwater pit outside No. 11. This stormwater pit is the head of a spur to the stormwater network flowing down View Point Road. The stormwater pit was flowing. It was known by Mr. Hutchings that the network of AG pipes was required because of spring(s) within the property.

Figure 34: 20/6/25 7 Prospect Hill Road looking east showing gully pot where AG pipes from the property meet, flowing to Stormwater Pit outside No. 11.

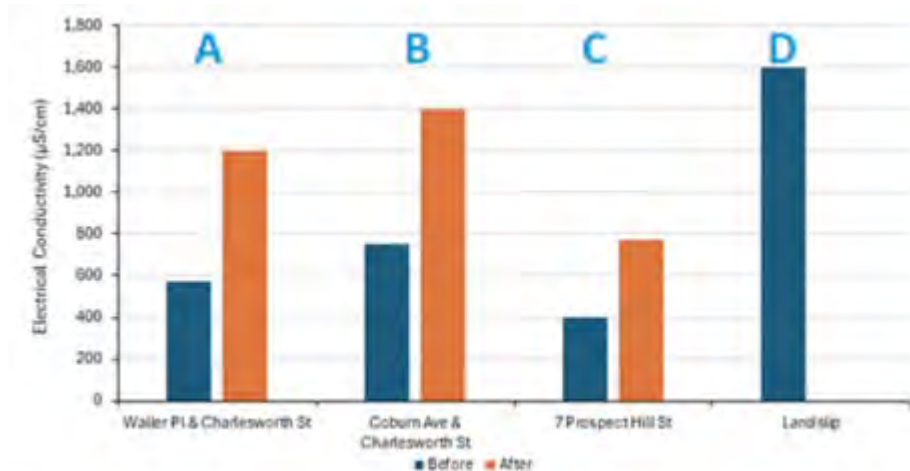
Figure 11 shows EC changes for the selected sample location shown in Figure 10 for EC values prior to / shortly after repairing the SEW burst compared to EC values post repair, which show a substantial increase in EC levels

as groundwater quality in the shallow perched aquifer returns to background water quality. In fact, it can be seen that in each case, the post-repair EC is almost exactly double the pre-repair value.

Figure 11: Summary of EC for selected sample locations showing Before and After Fix of Burst Pipe area

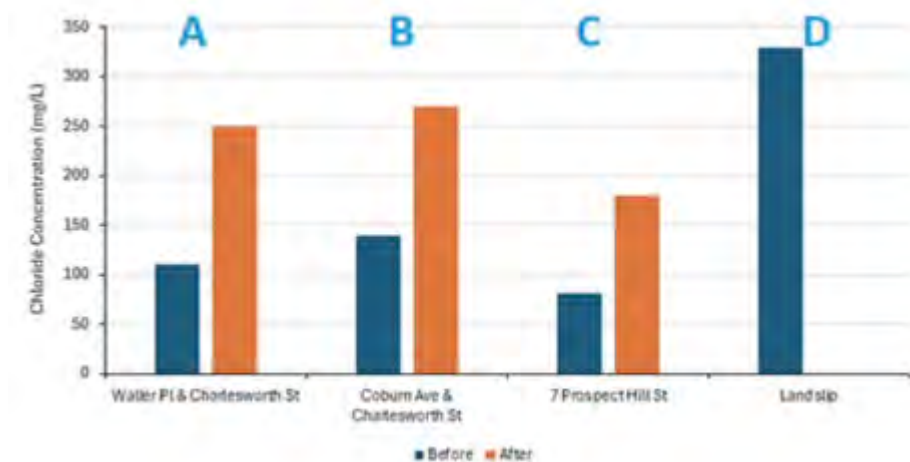
A similar proportionate change in concentrations is also observed for chloride, as shown in Figure 12.

Figure 12: Summary of Chloride Concentration for selected sample locations showing Before and After Fix of Burst Pipe

Overall, the increase in EC, and chloride, post repair of the burst pipe shows similar ratios.

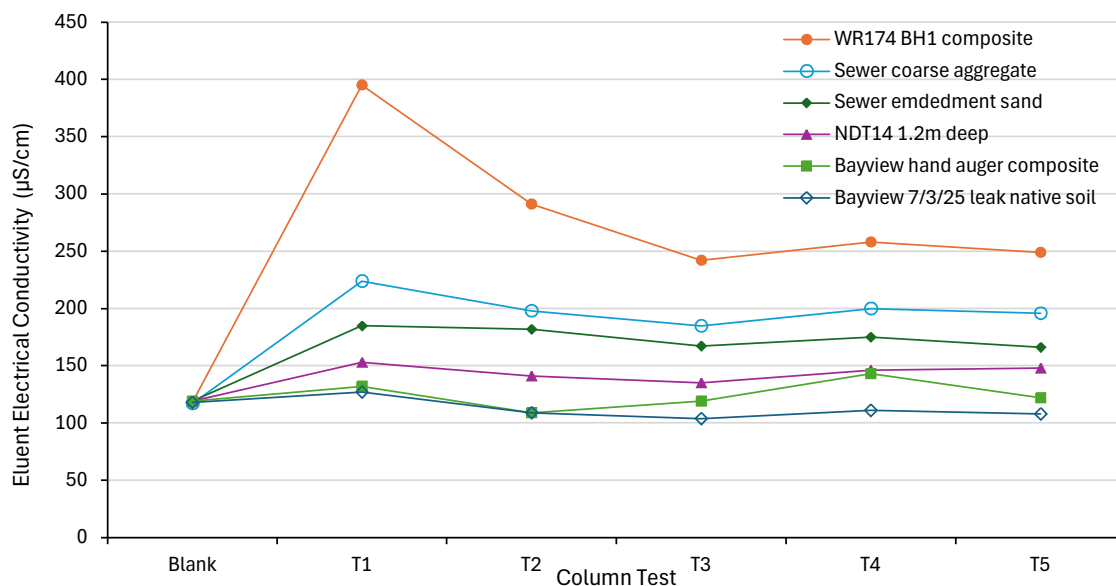
- Samples for the Sewer coarse aggregate and Sewer embedment sand showed an increase in EC concentrations in the initial eluent compared to the blank concentration. However, the concentrations in the subsequent samples remained relatively constant. While the increase in EC is noticeably less than WR174 BH01 Composite, the sewer bed aggregate material shows some increase in EC.

- The eluent from the native soil samples (i.e., Bayview) showed no significant changes in EC concentrations relative to their respective blanks.

Figure 13: Electrical Conductivity Column Test Eluent Concentrations

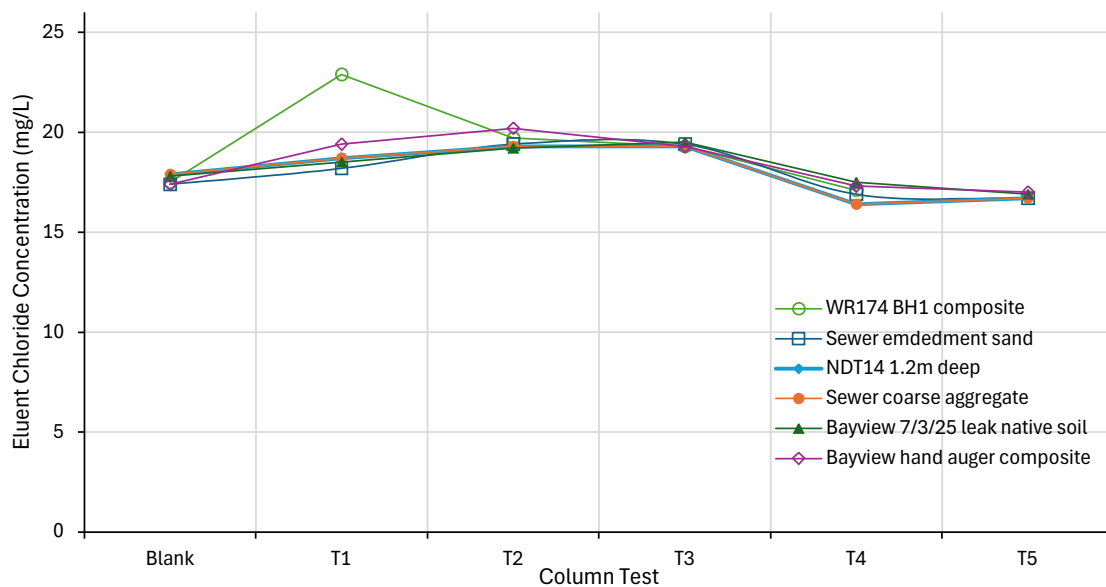
Chloride can also be considered as a tracer chemical (because it is very soluble and does not readily adsorb to mineral surfaces or exchange onto charged clay particles), and the data obtained from the column tests does support this conclusion. That is, while chloride is also present in the background water samples the column tests did not show a significant difference in changes of chloride concentrations along a pathway, it is expected that it would be reflected across different profiles in a similar ratio. This is shown in Figure 14, as there is a close profile correlation in chloride concentrations across all different samples assessed. It is noted that the T1 sample for WR174 BH1 composite showed an increase in concentration; however, overall it followed a similar trend compared to all other samples.

Figure 14: Chloride Eluent Column Test Eluent Concentrations

The column test data is consistent with the groundwater results assessed for the project. That is, the lower geological unit, represented by the sample ID WR174 BH1 composite showed the most significant changes in EC which is consistent with the EC measured at this location as part of the groundwater sampling event (e.g., EC maximum of 5,200  $\mu\text{S}/\text{cm}$ ).

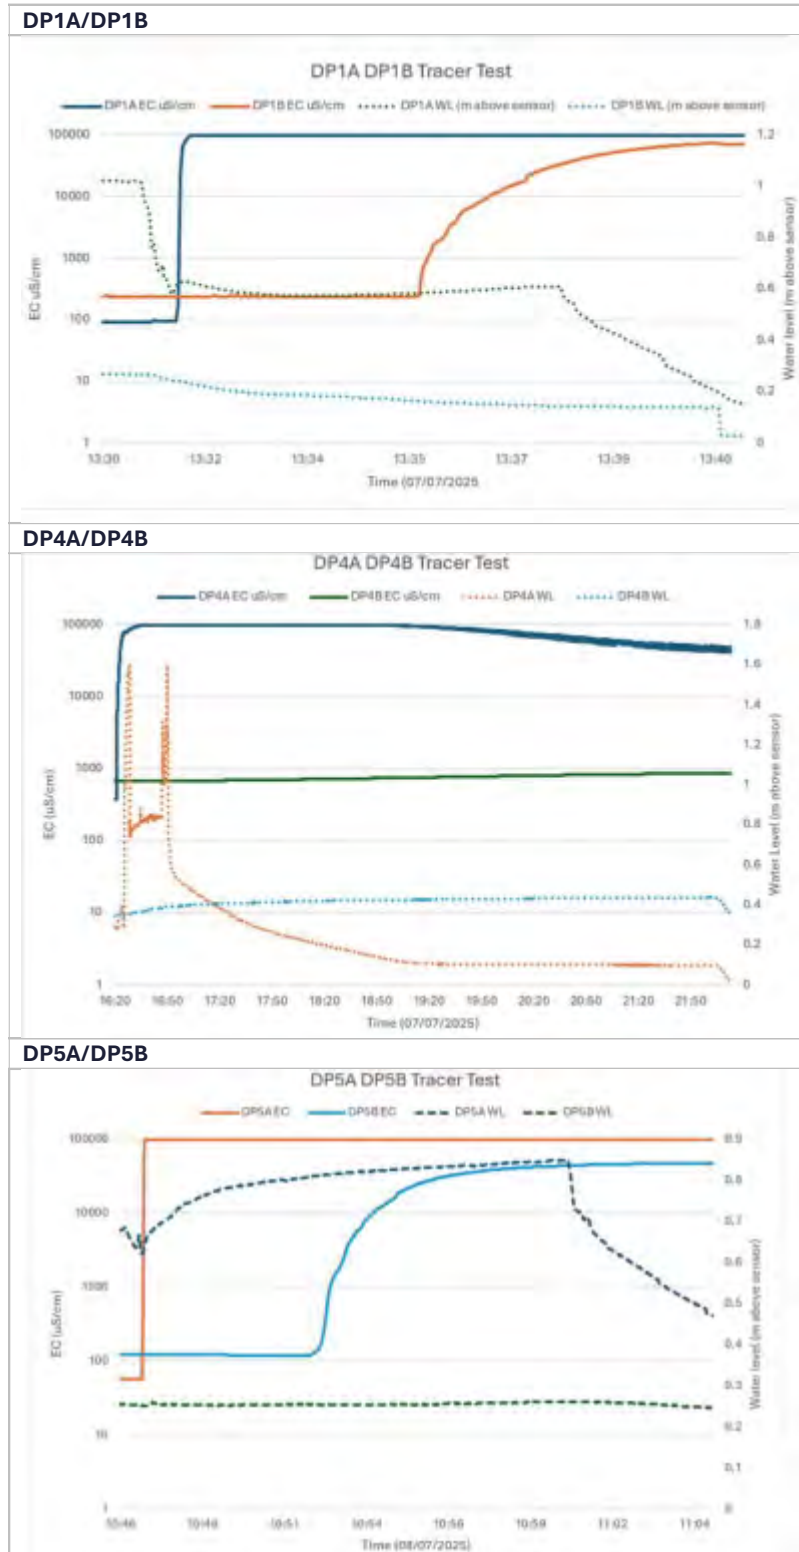
Tracer test results are present in Table 12 and graphically in Figure 15. Both DP1A/DP1B and DP5A/DP5B show clear responses indicating the ability of the embedment material to transmit water. It should be noted that the head differences that occurred during the test are higher than what would be experienced in reality therefore the travel times should be treated with this in mind.

Figure 15: Tracer Test Plots

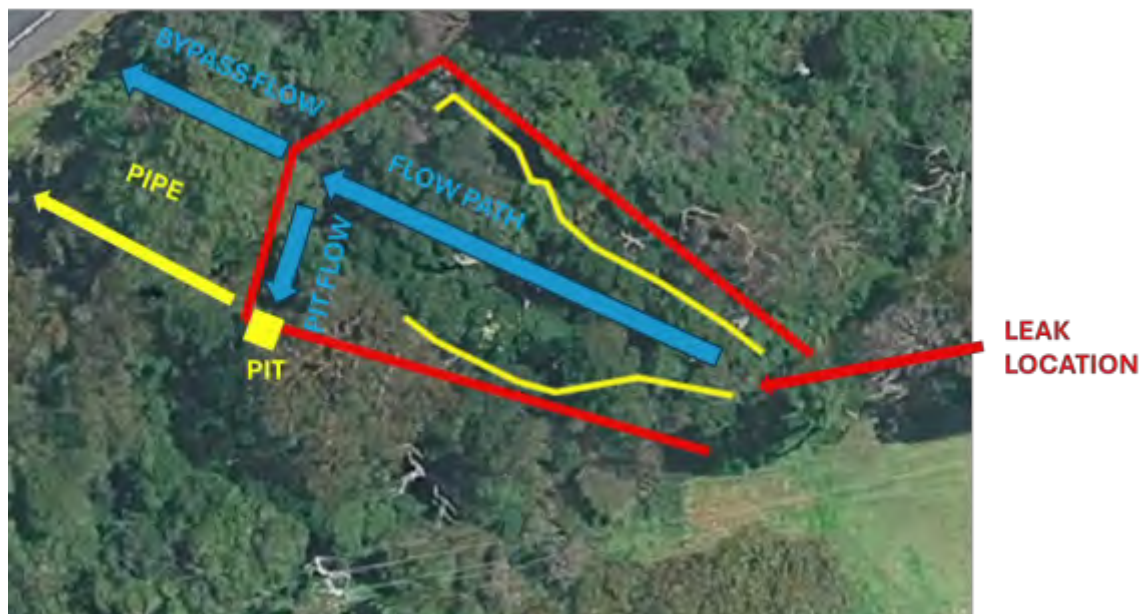
The extent of the surface flows is estimated to be delineated by the extent of sandy materials deposited across the surface downstream of the leak location. The key features are shown on Figure 1.

Figure 1: Estimated Sand Deposition Extent

The extent of sand deposition is delineated by the red lines in the above image. An example of the sand deposition area as viewed on the ground is presented in Figure 2.

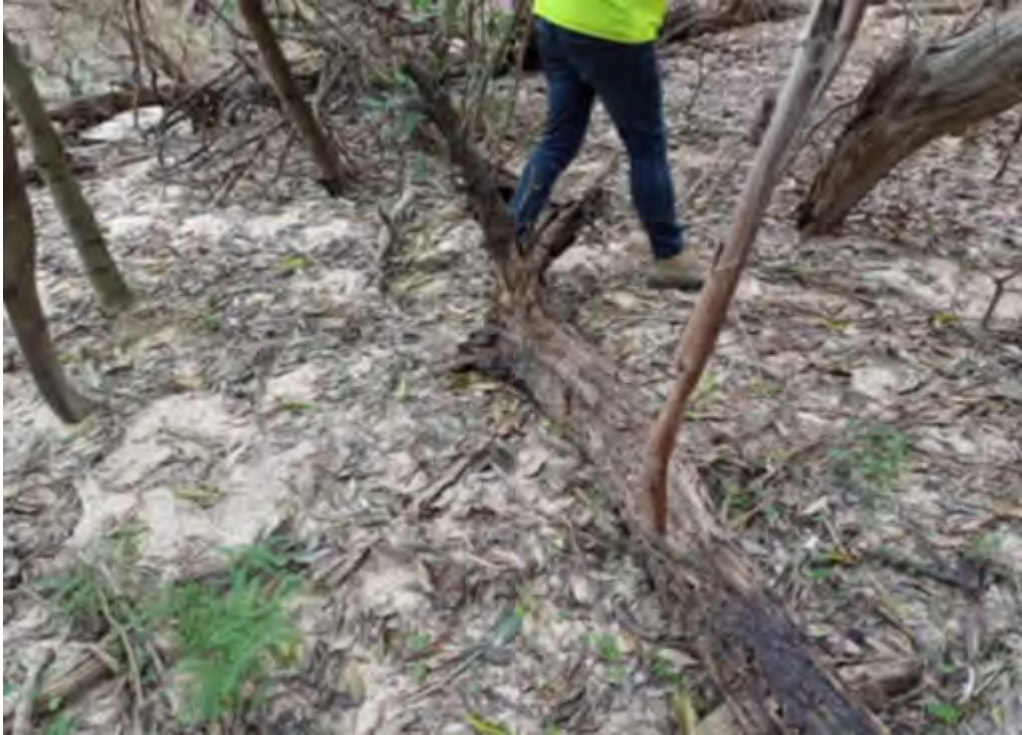
Figure 2: Example of Sand Deposition

The image presented above shows that the sand depositions area has a characteristic colour, overlies leaf litter and is largely free of vegetation. The appearance is different to that of adjoining regions which are characterised by a greater vegetative coverage, darker colour and a greater depth of leaf litter across the surface.

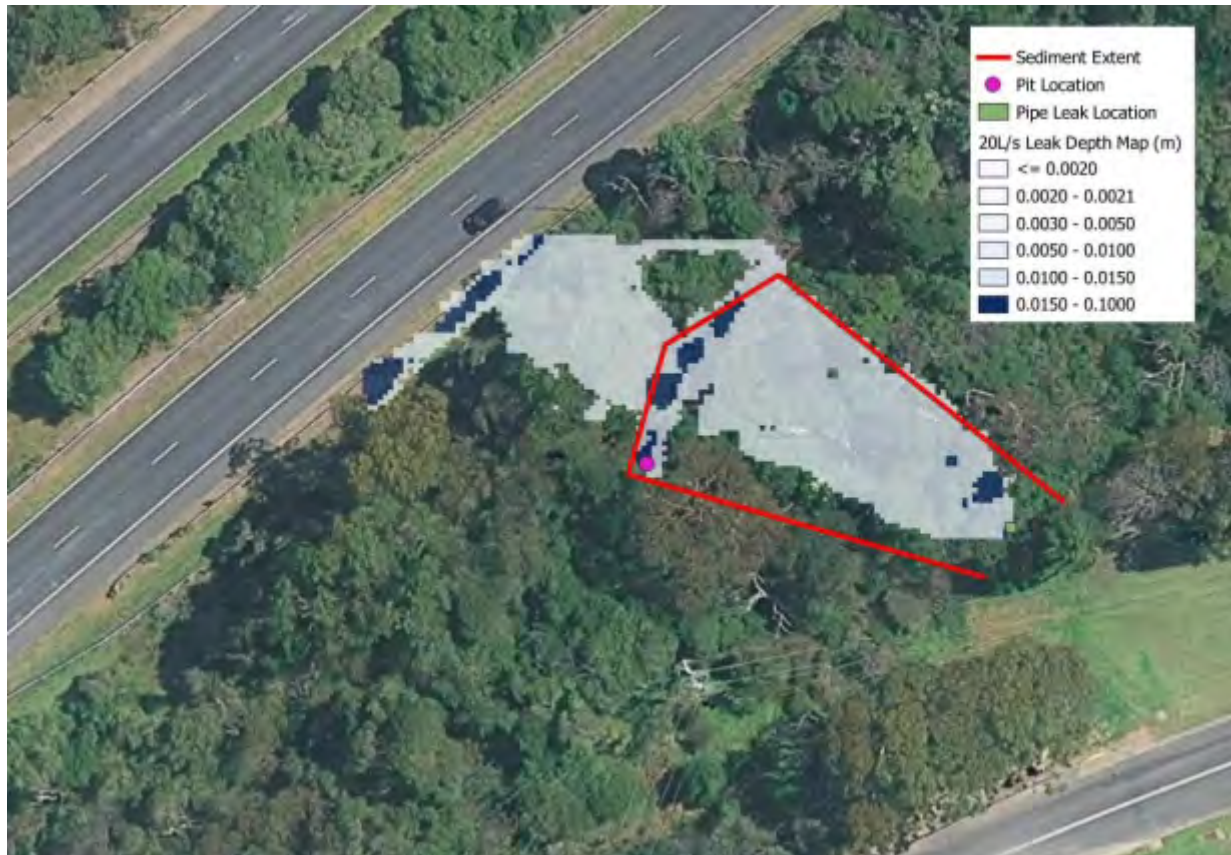
Figure 5: 20L/s inundation extents

The outcomes indicate that the flood extent is similar to the observed extent of sediment deposition (red line). The outcomes indicate that the majority of the estimated outflow of 16 L/s would have travelled across the surface.

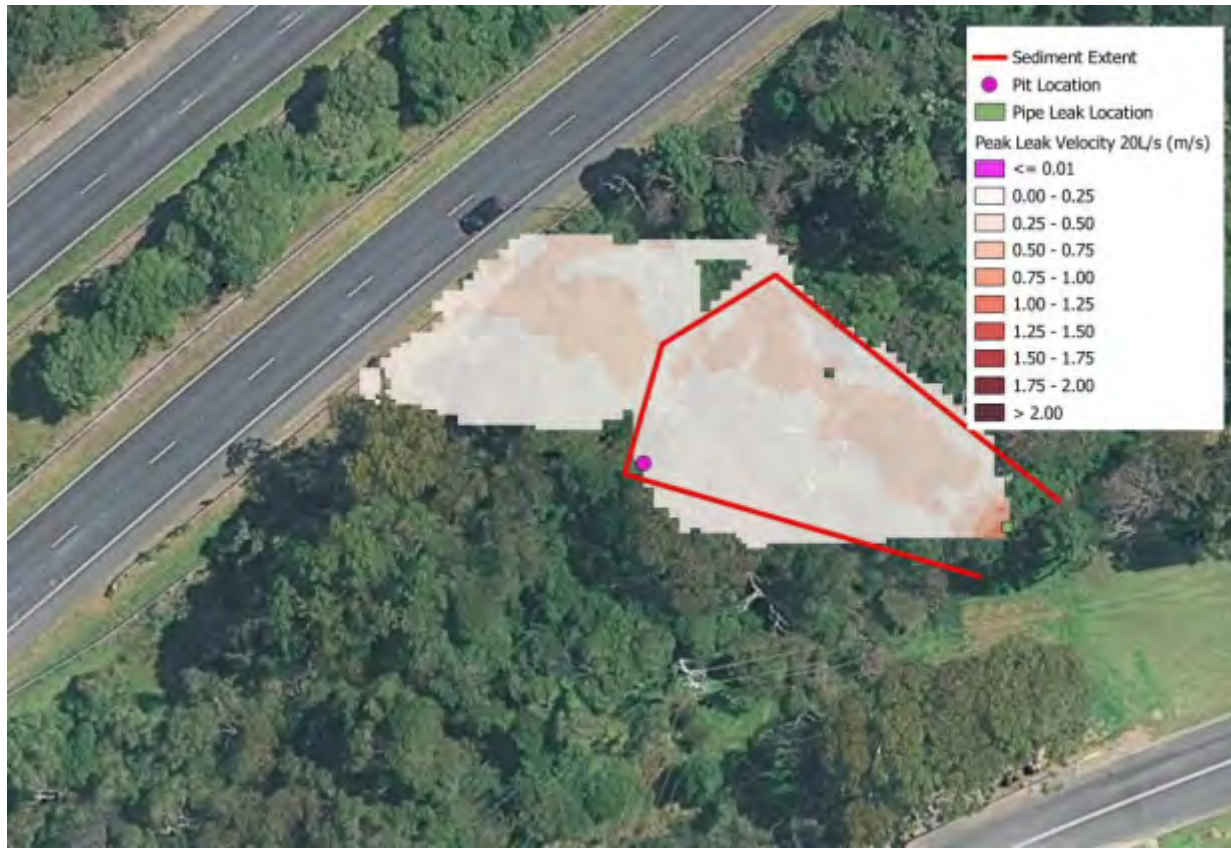
Figure 6: 20 l/s maximum velocities

Note that the velocities in the above figure cover a broader extent than that shown in the flood maps because velocities are shown for all depths, while the flood maps do not show depths less than 2 mm. The maximum velocities are around 0.5 m/s. This is consistent with a maximum diameter of around 1 mm for transported sediments.

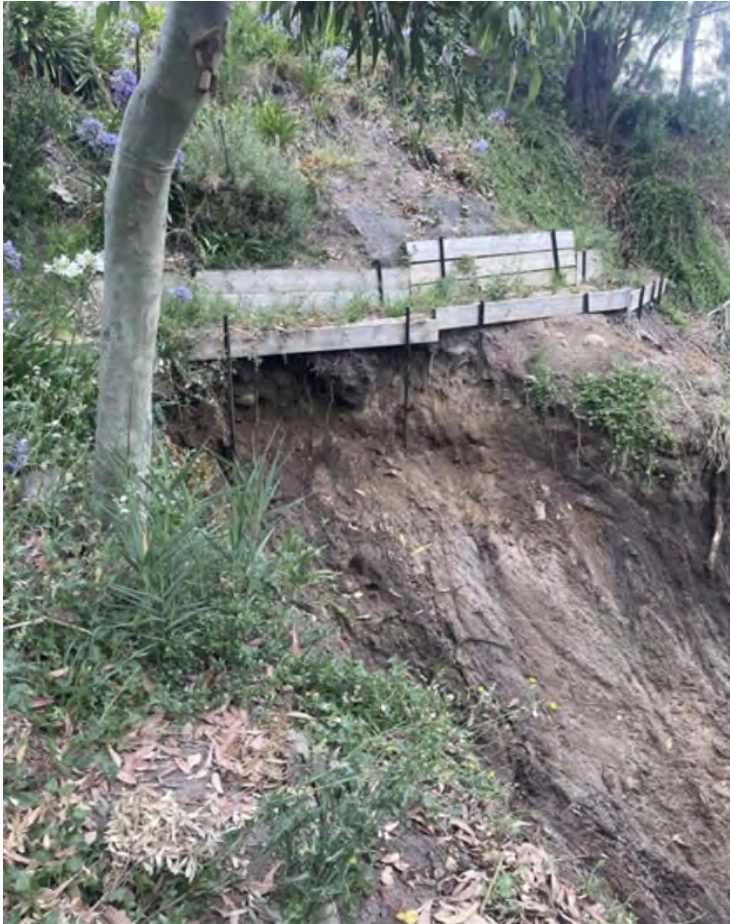
Figure 4: Photo taken by SEW personnel on 6 January 2025 showing detail of backscarp of landslide

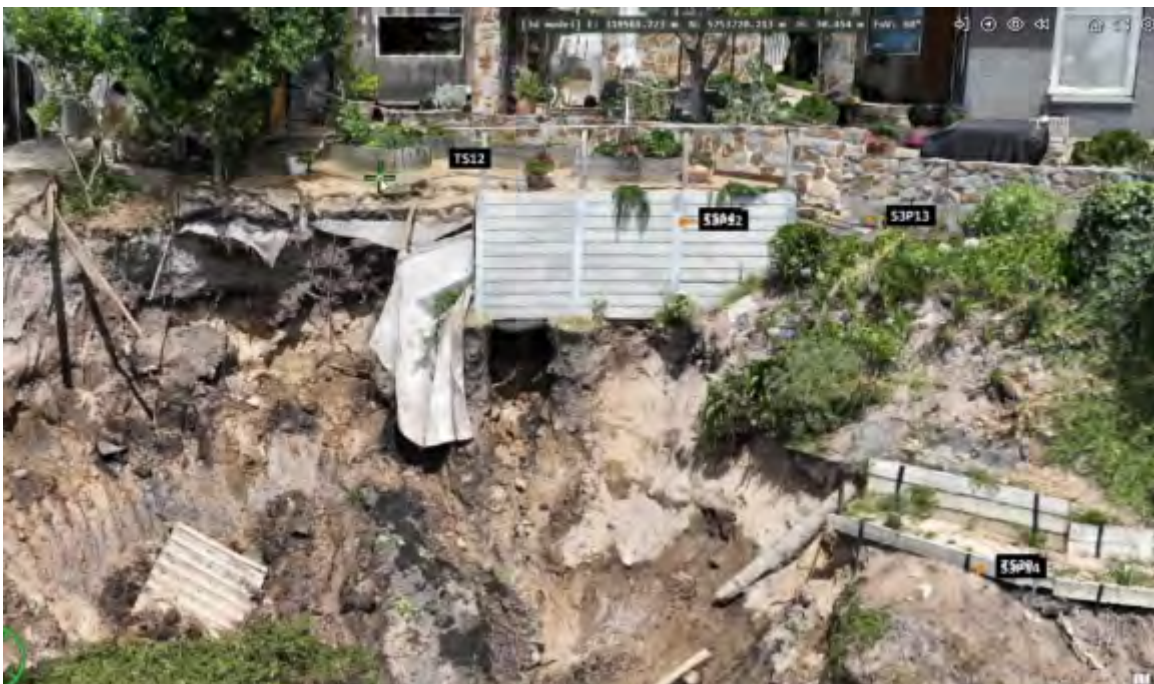
Figure 5: Drone footage of the retaining wall on 16 January 2025

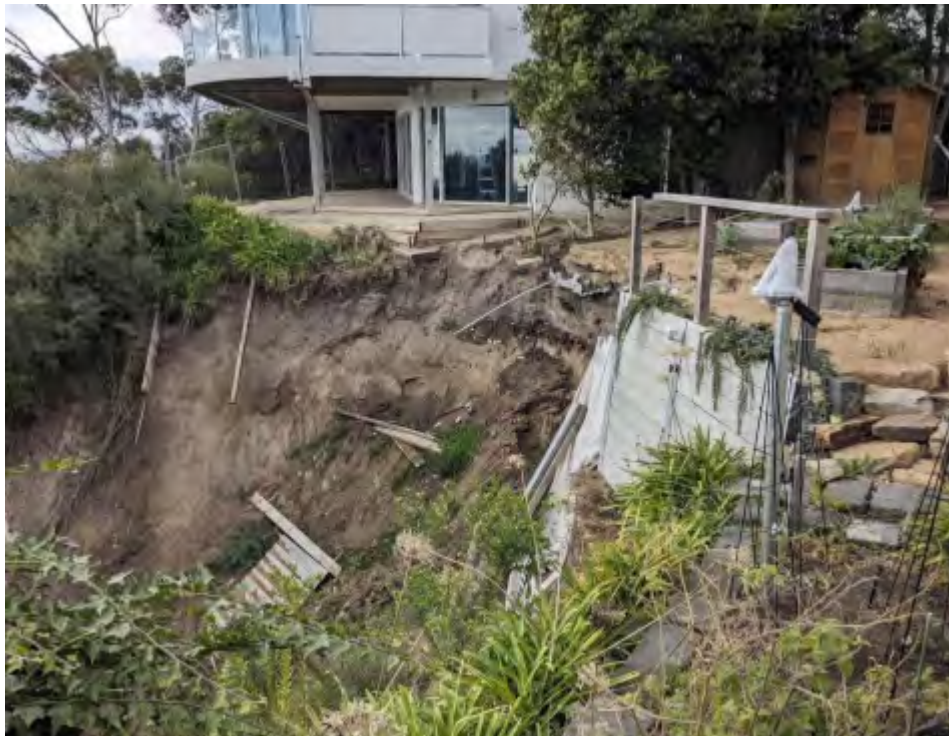
Based on BH01 and BH02 by PSM, the ground at 10 View Point Road comprised granular fill material overlying inferred granular colluvium material, underlain by residual granite recovered as Clayey SAND or Sandy CLAY and grading into XW granite as depth increases. Figure 7 and Figure 8 shows the post-failure condition of the slope. It can be seen that as surficial material (inferred colluvium soil) slipped down along the slope, weathered rock was daylighted under the retaining wall. Based on Figure 8 and site observations, the thickness of the inferred colluvium soil above weathered rock was approximately 1-2m.

Figure 7: Site photograph looking at backscarp facing 6 View Point Road

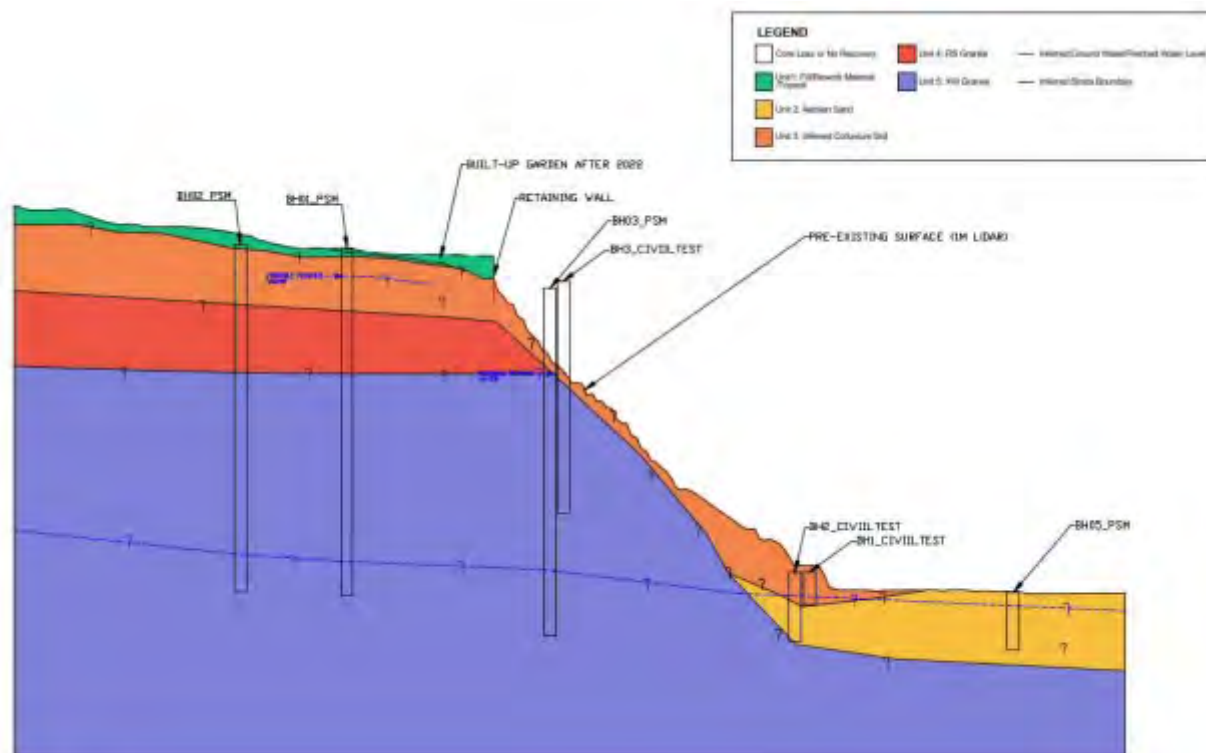
Figure 9: Ground model of assessed section (not to scale)

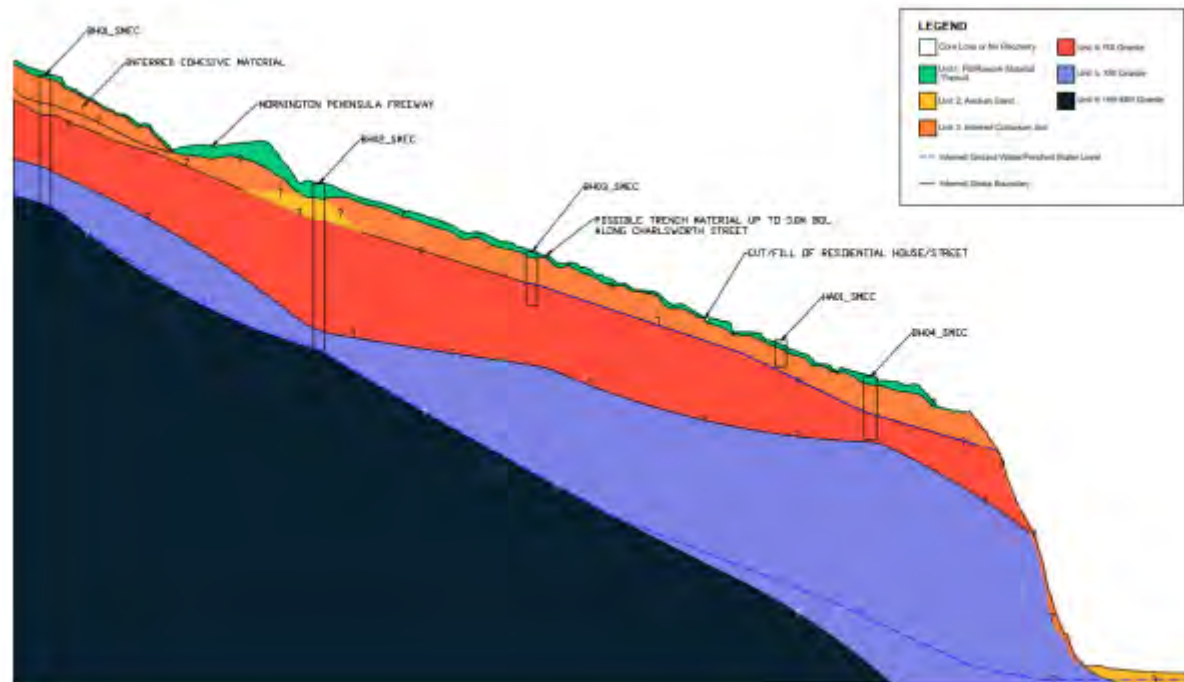
Figure 11: Ground model of site locality (not to scale)

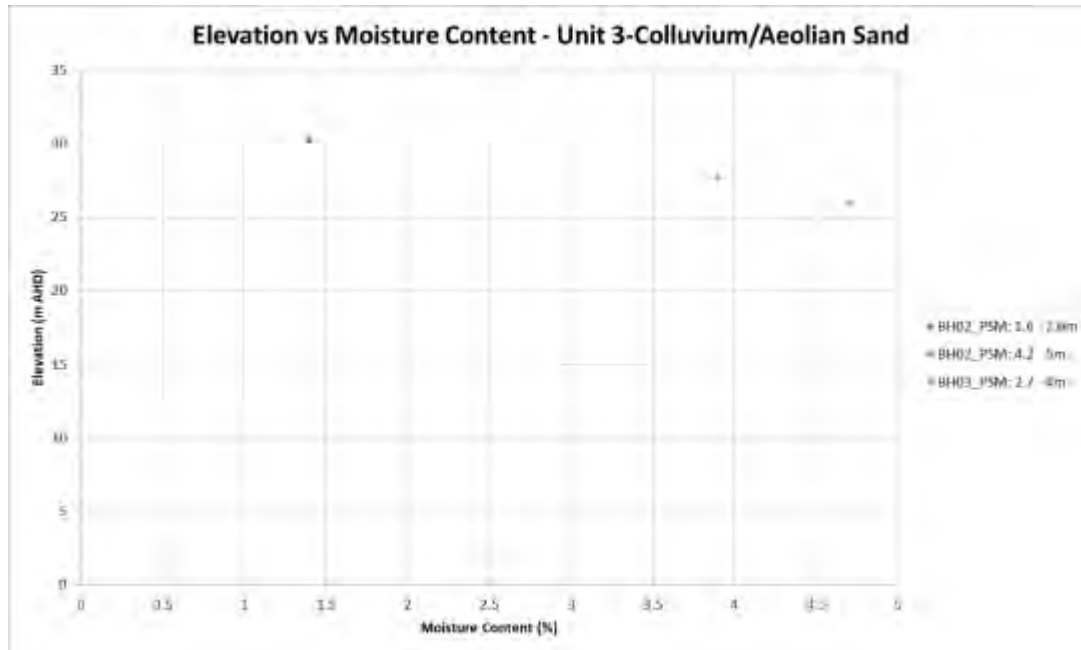
Only two moisture content tests were performed on Unit 3 materials, showing in Figure 12. It can be seen that the results of the tested samples had less than 5% moisture content. Note that material in BH03\_PSM at 2.7 m was logged as wet soil.

Figure 12: Unit 3 moisture content plot

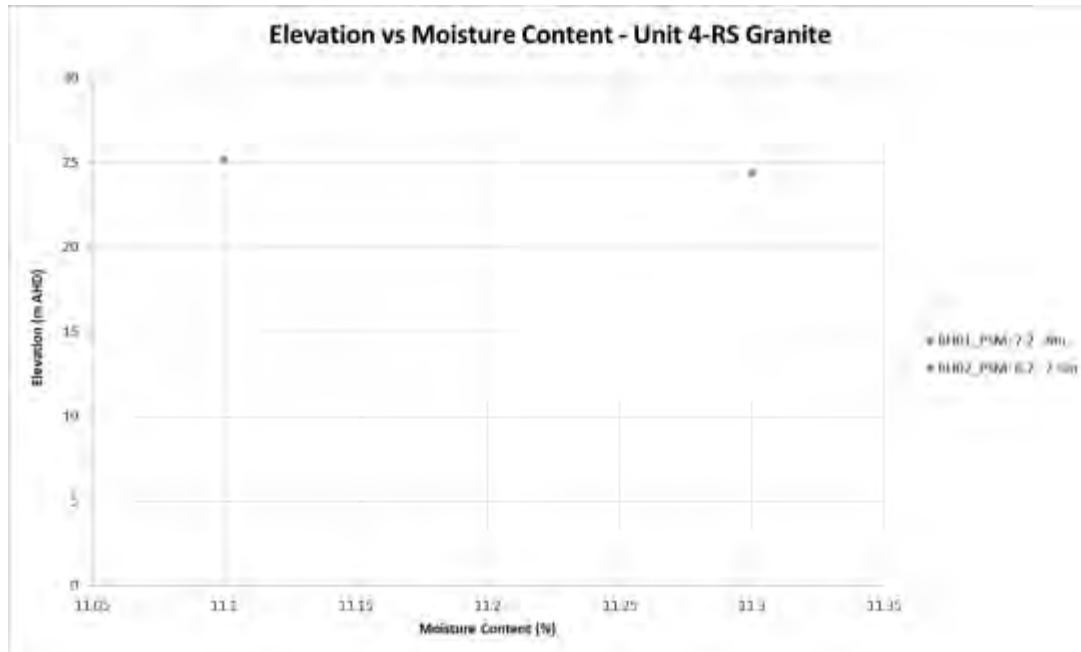
Only two moisture content tests were performed on Unit 4 materials, showing in Figure 13. It can be seen that the tested Unit 4 materials had less than 11.5% moisture content.

Figure 13: Unit 4 moisture content plot

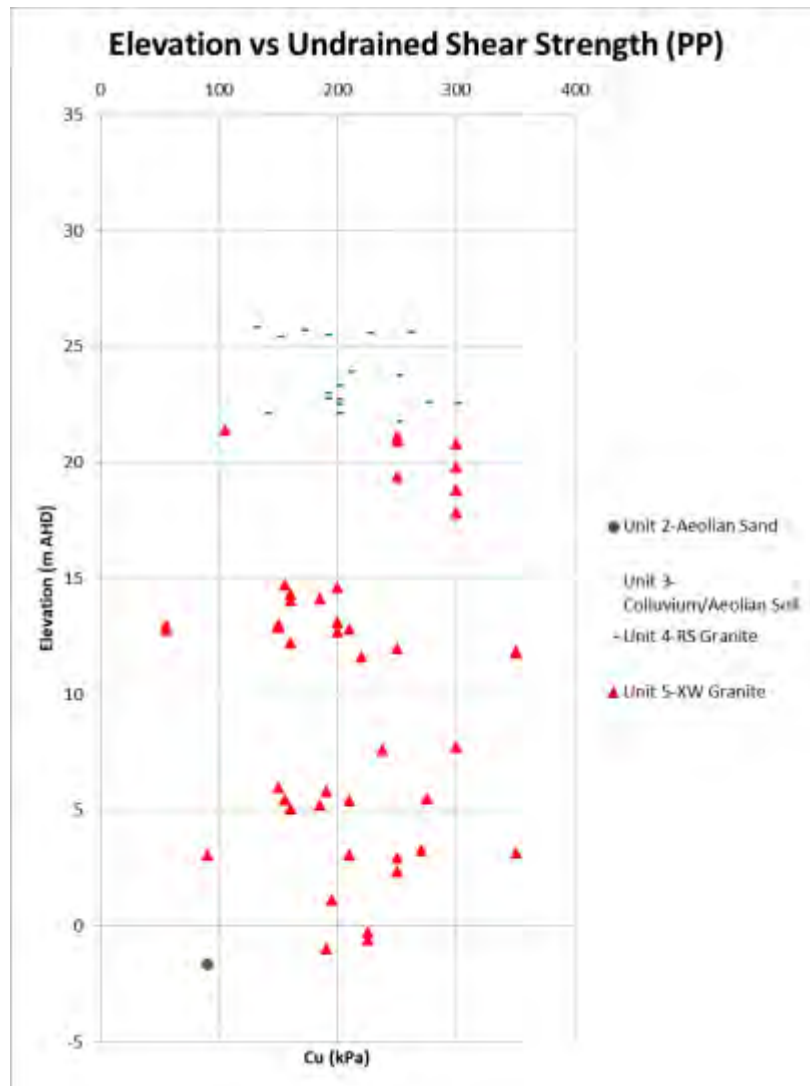
Figure 14: Pocket penetrometer result plot
