Multidisciplinary Expert Supplementary Report

# Board of Inquiry into McCrae Landslide

Prepared for: Thomson Geer

21 July 2025

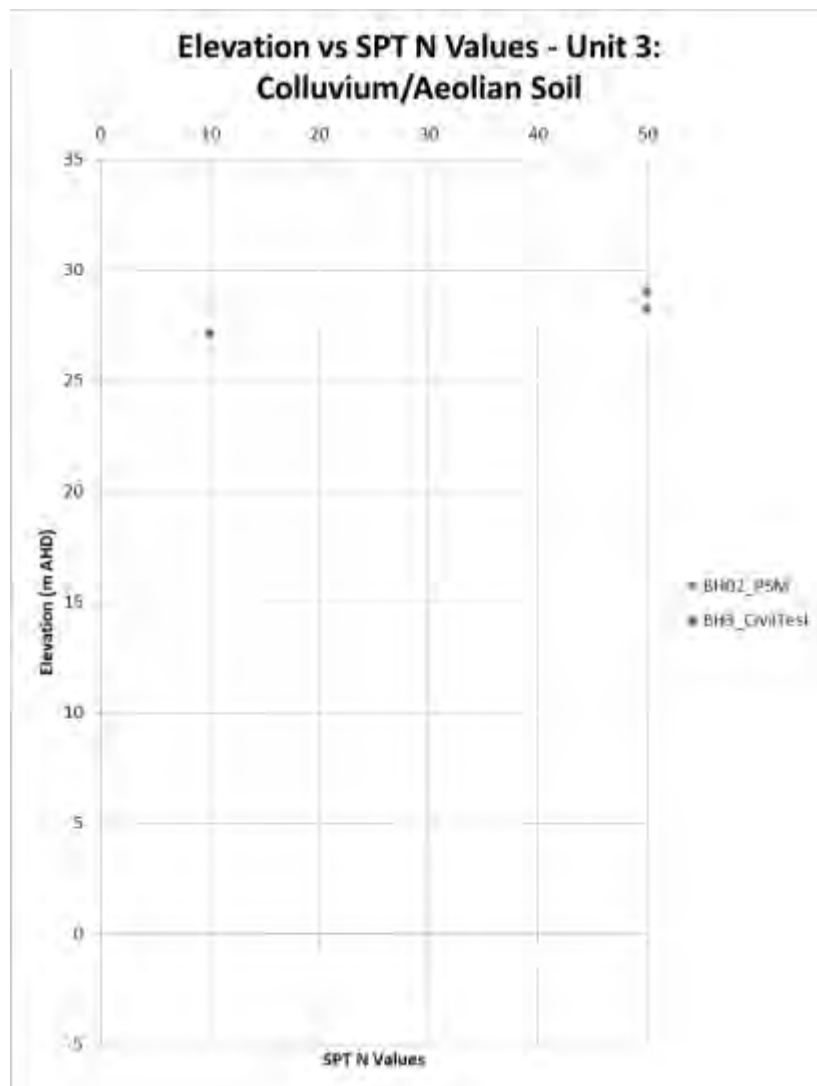
- All SPT in Unit 3 soil were conducted within granular material. SPT in BH02\_PSM refused which was potentially due to the presence of gravel;
- Only one SPT in Unit 4 soil was conducted within cohesive material which had SPT N value of 12 indicating consistency of stiff. All other SPTs had N value of 25 to 33, indicating relative density of medium dense to dense;
- Due to the limited amount of data, it is difficult to derive soil parameters from SPT results.

Figure 15: Unit 3 SPT plot

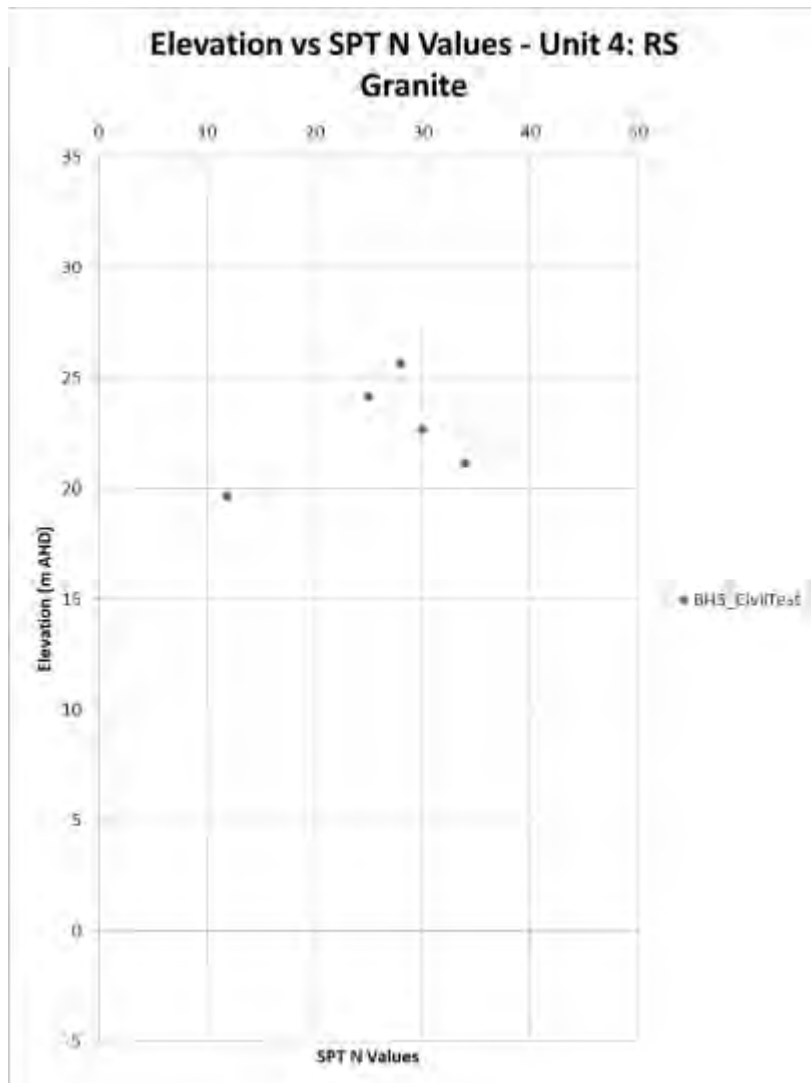
Figure 16: Unit 4 SPT plot

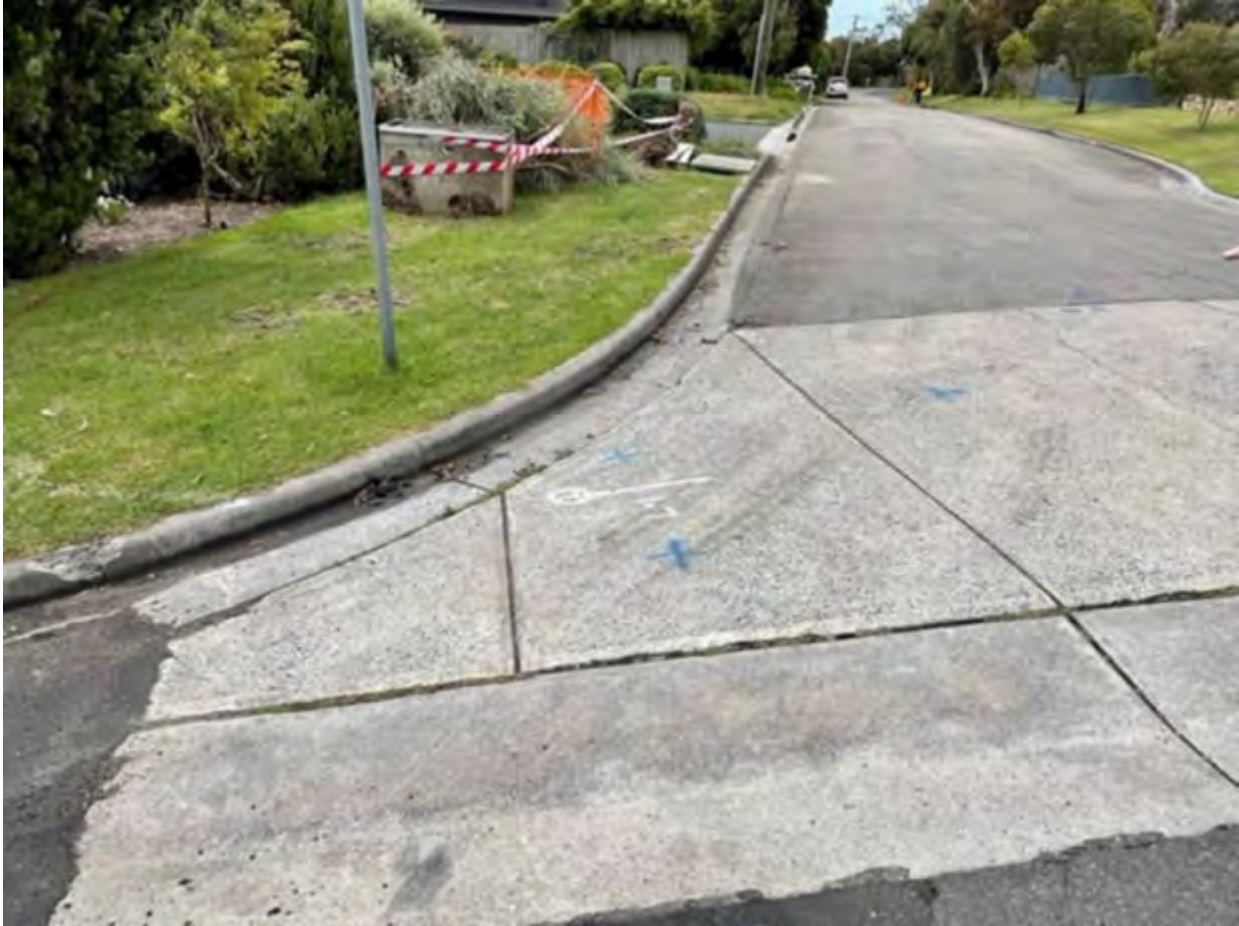
Figure 24: Photograph from email of 22 November 2022, looking north from Coburn Avenue towards Prospect Hill Road showing undulating concrete pavement construction.
